2019 Jeep Compass Latitude

Odometer: 66,882
Engine: 2.4L I4 MultiAir
Color: Granite Crystal Metallic Clearcoat
Interior: Black Cloth

Transmission: 6-Speed Aisin Automatic
VIN: 3C4NJCBB8KT676592
Stock #: 1C261970AV
Drivetrain: FWD

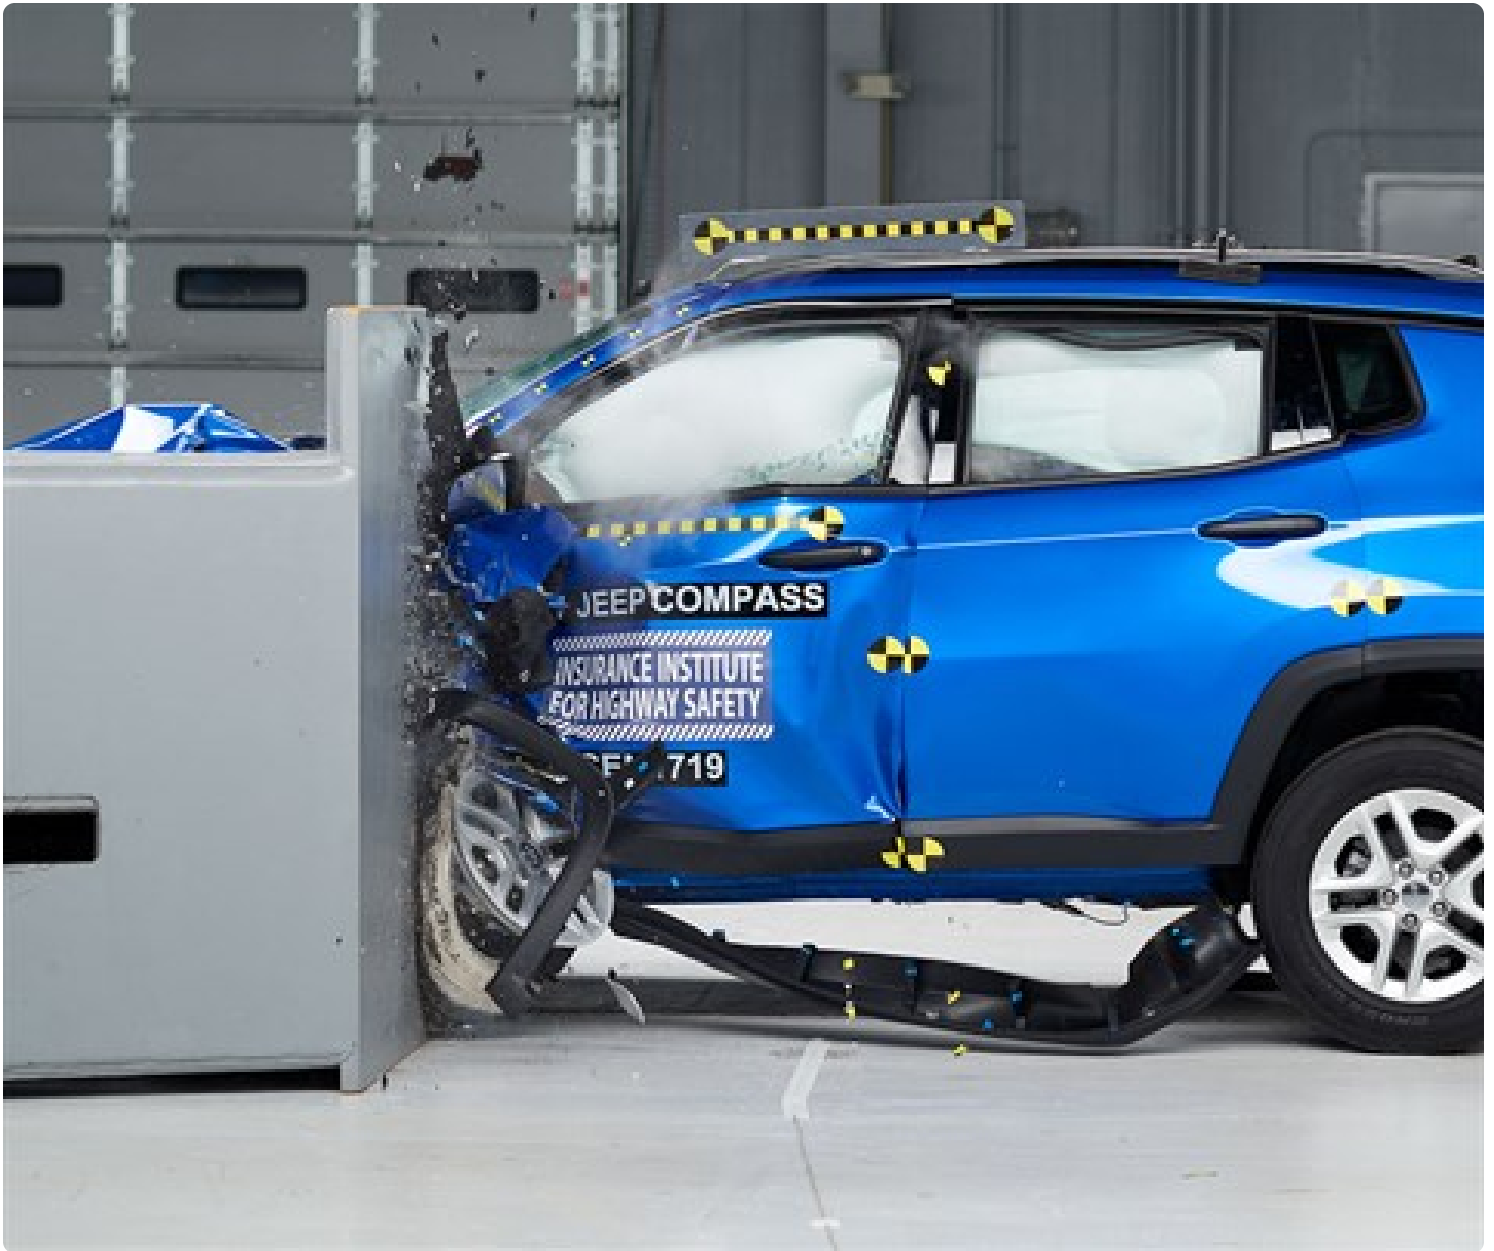
Action shot taken during the driver-side small overlap frontal crash test.

Overall evaluation	G
Structure and safety cage	G
Driver injury measures	
Head/neck	G
Chest	G
Hip/thigh	G
Lower leg/foot	G
Driver restraints and dummy kinematics	G

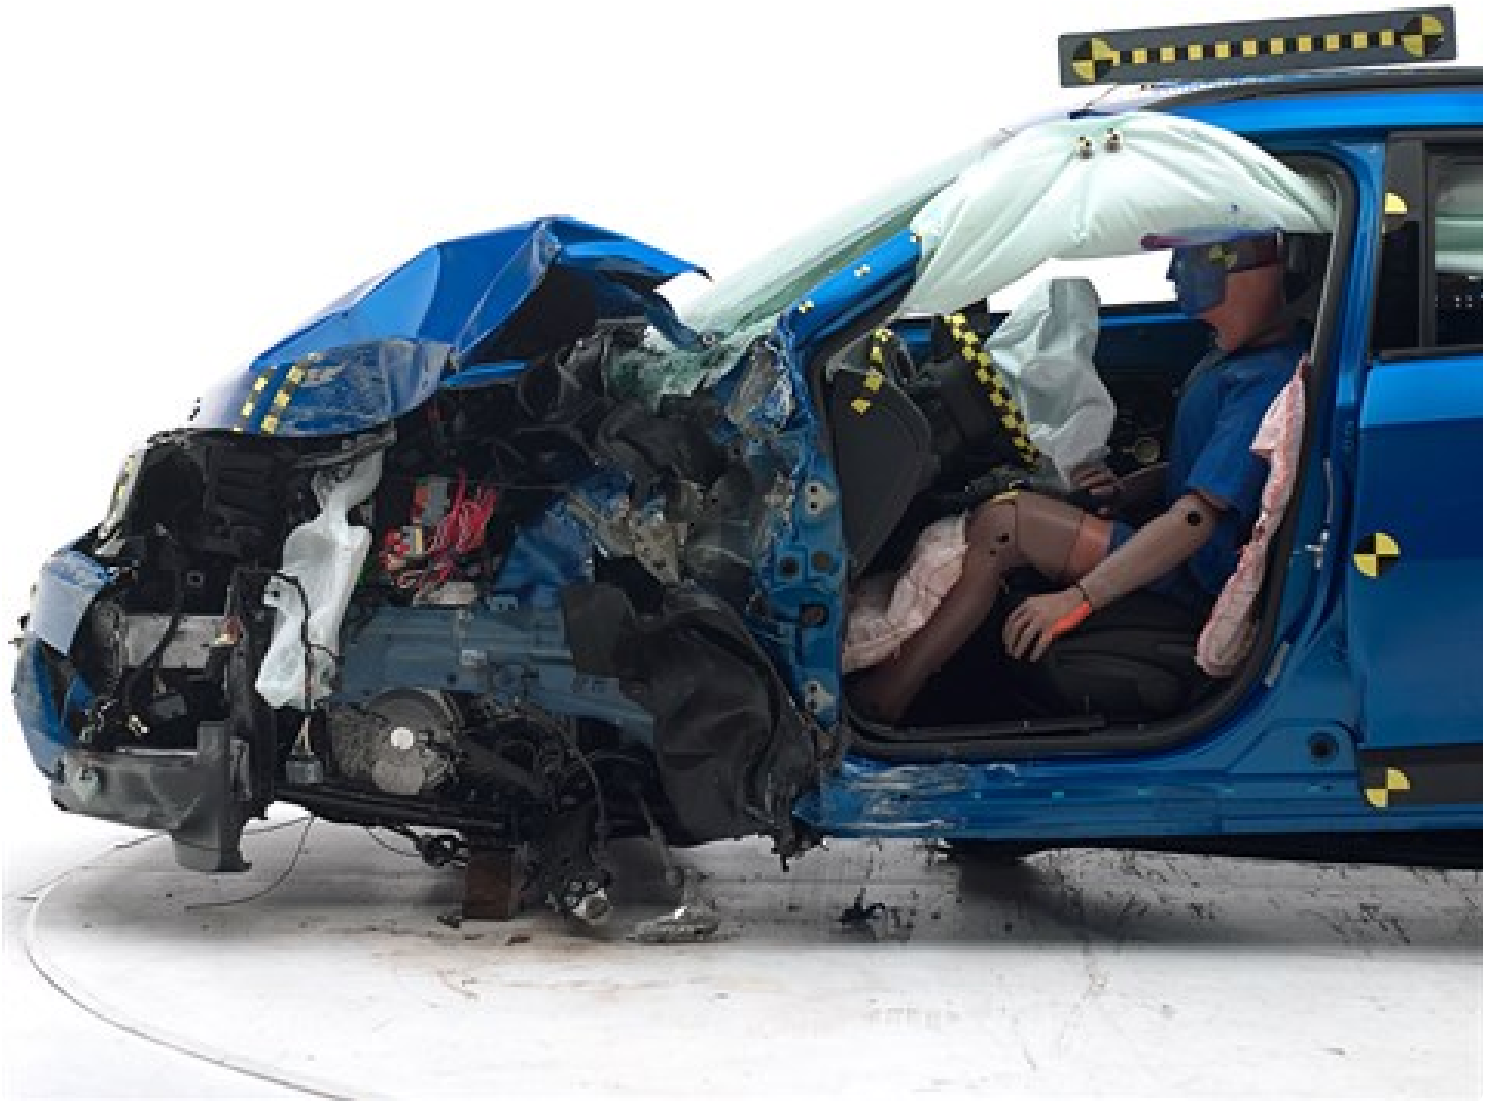
The dummy's position in relation to the door frame, steering wheel, and instrument panel after the crash test indicates that the driver's survival space was maintained very well.

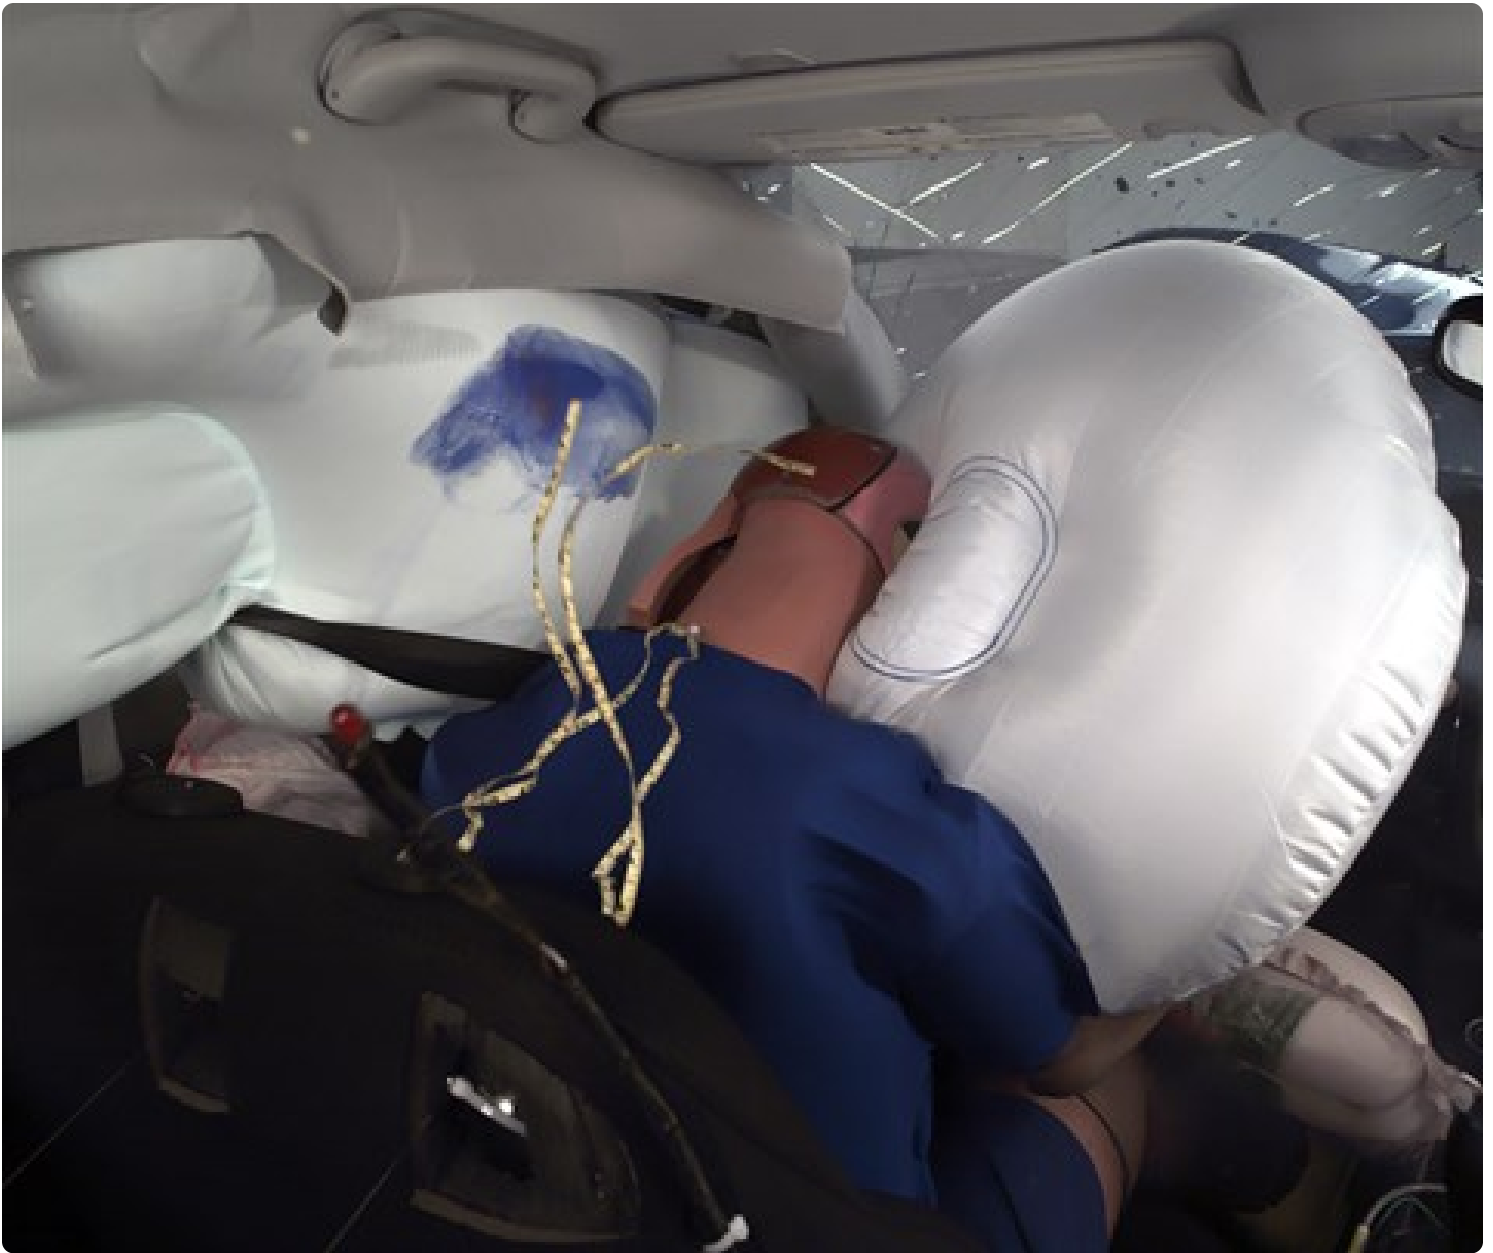
The frontal and side curtain airbags worked well together to keep the head from coming close to any stiff structure or outside objects that could cause injury.

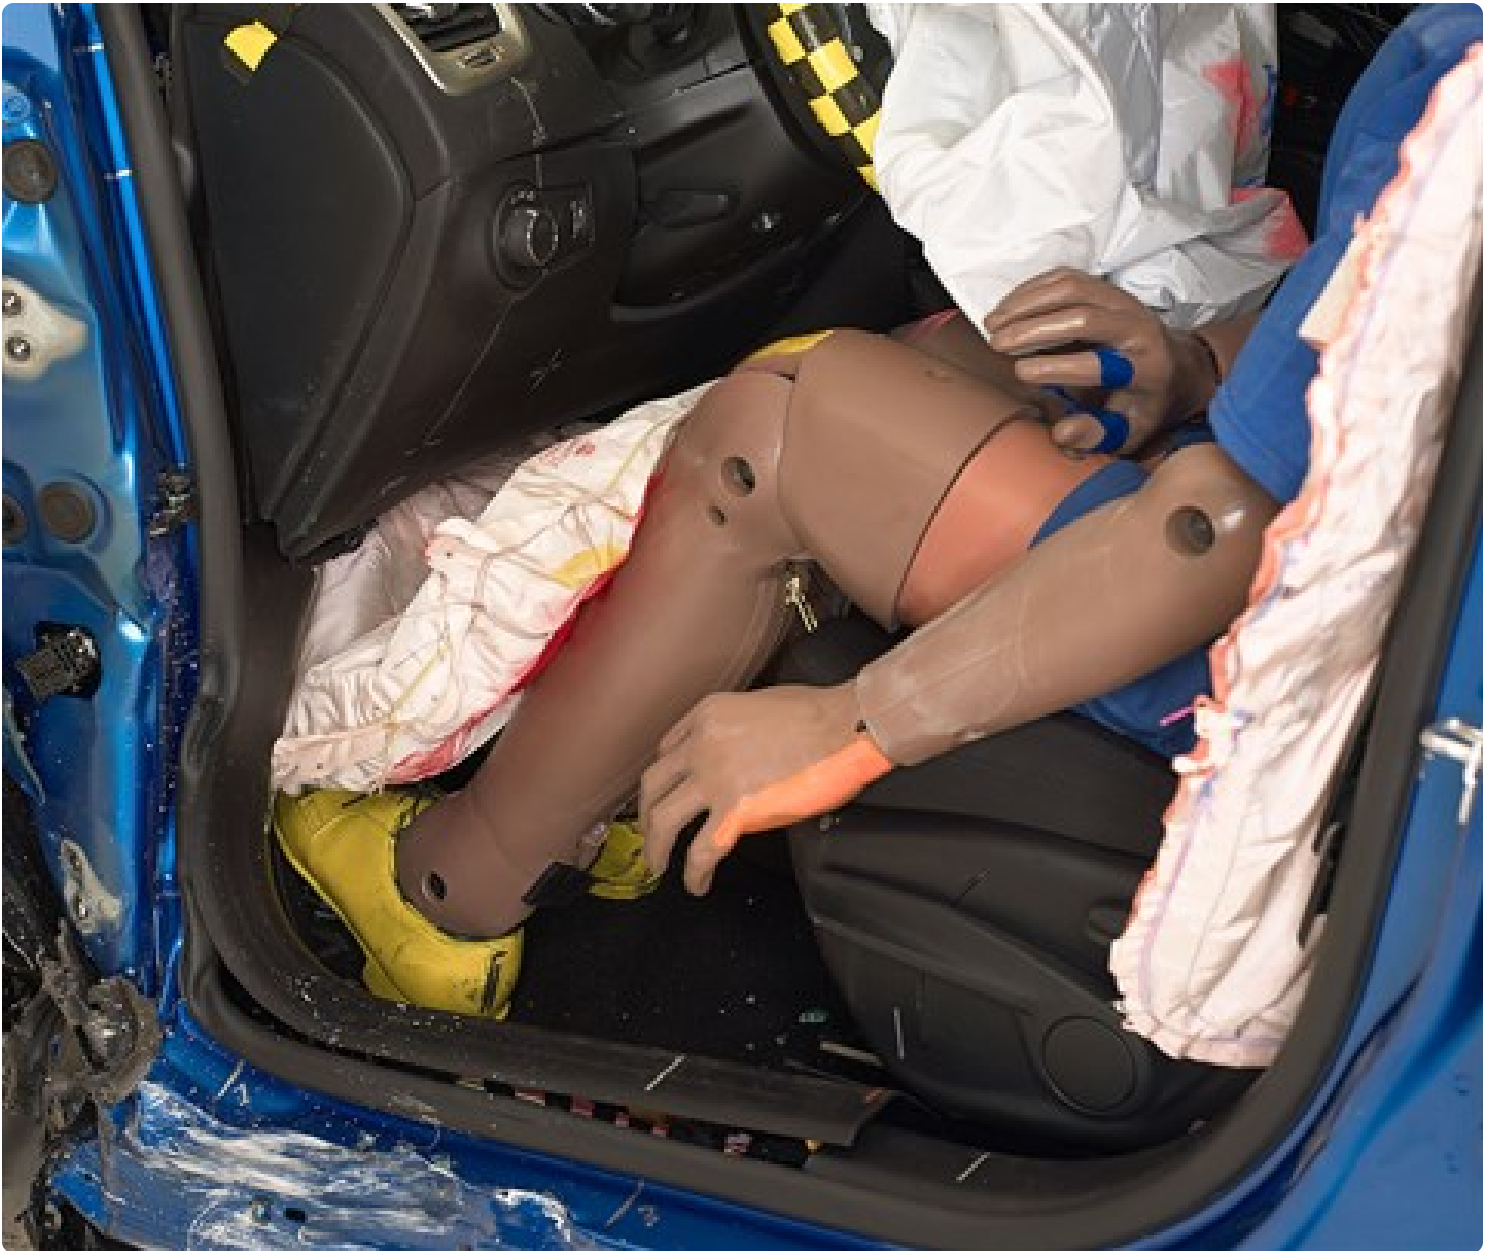
The driver's space was maintained well, and risk of injuries to the dummy's legs and feet was low.

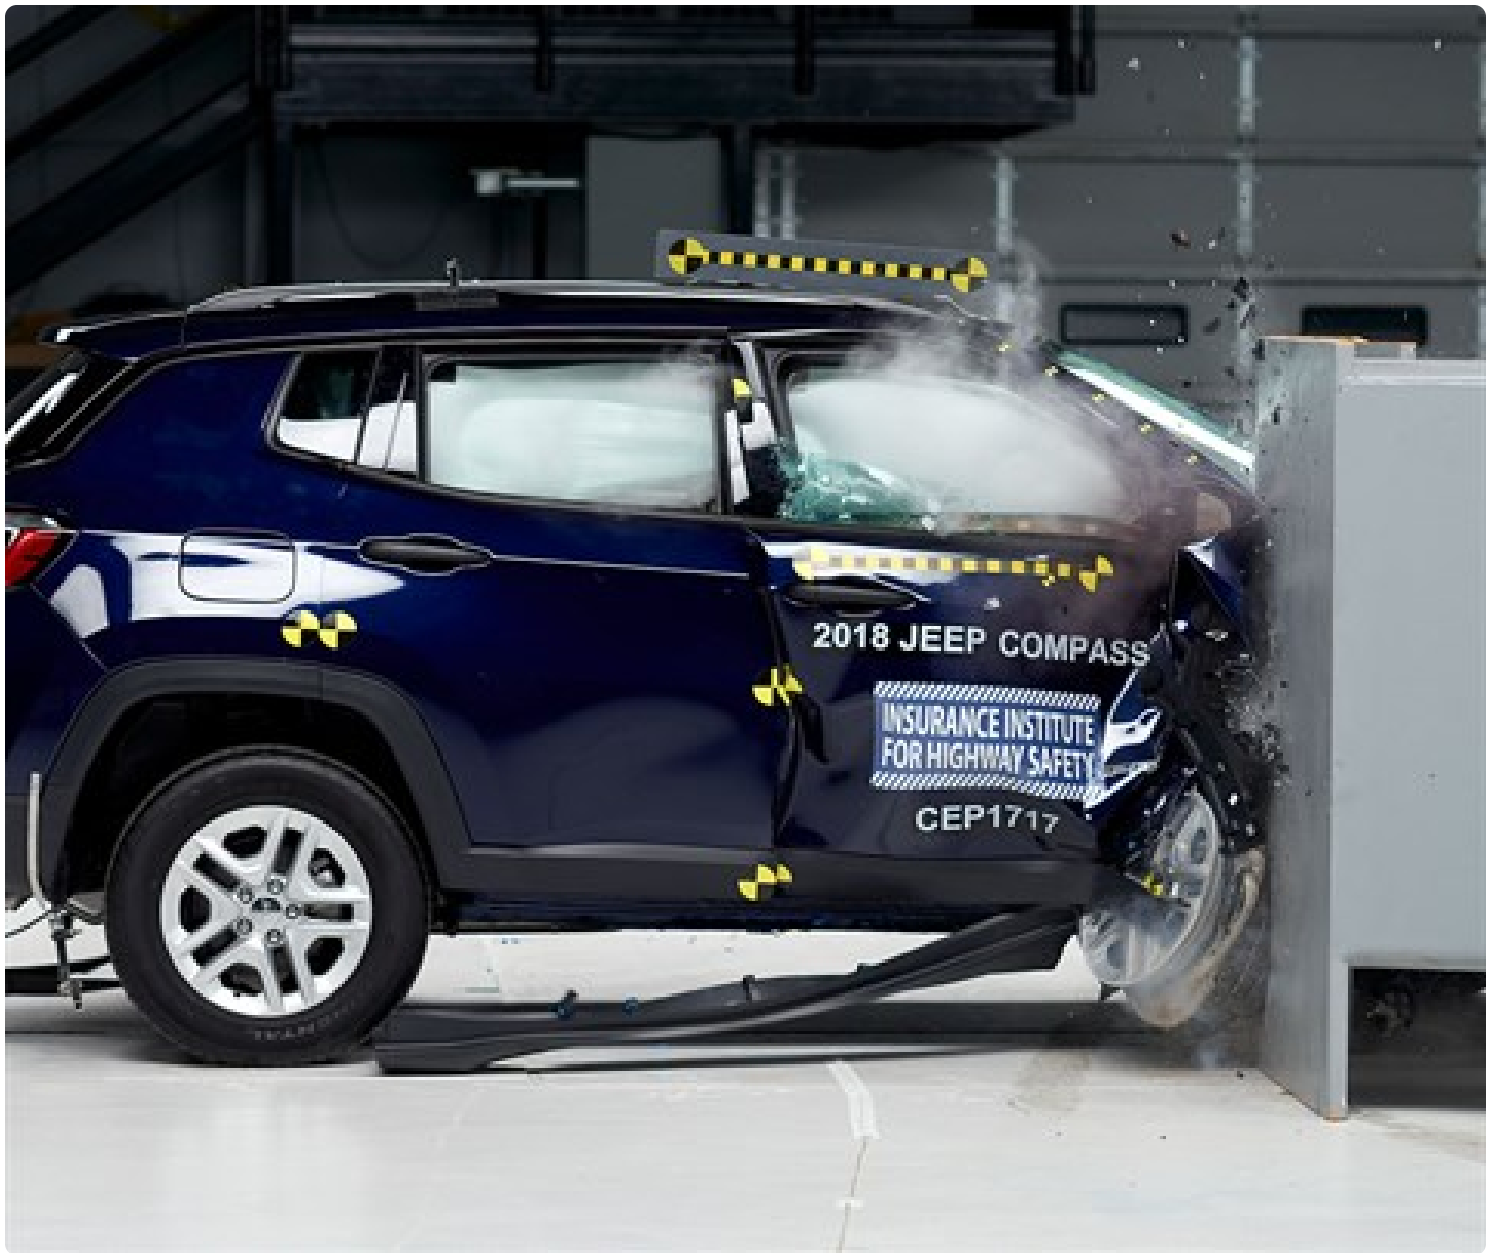
Action shot taken during the passenger-side small overlap frontal crash test.

Overall evaluation	G
Structure and safety cage	A
Passenger injury measures	
Head/neck	G
Chest	G
Hip/thigh	G
Lower leg/foot	A
Passenger restraints and dummy kinematics	G
Driver injury measures	
Head/neck	G
Chest	G
Hip/thigh	G
Lower leg/foot	G
Driver restraints and dummy kinematics	G

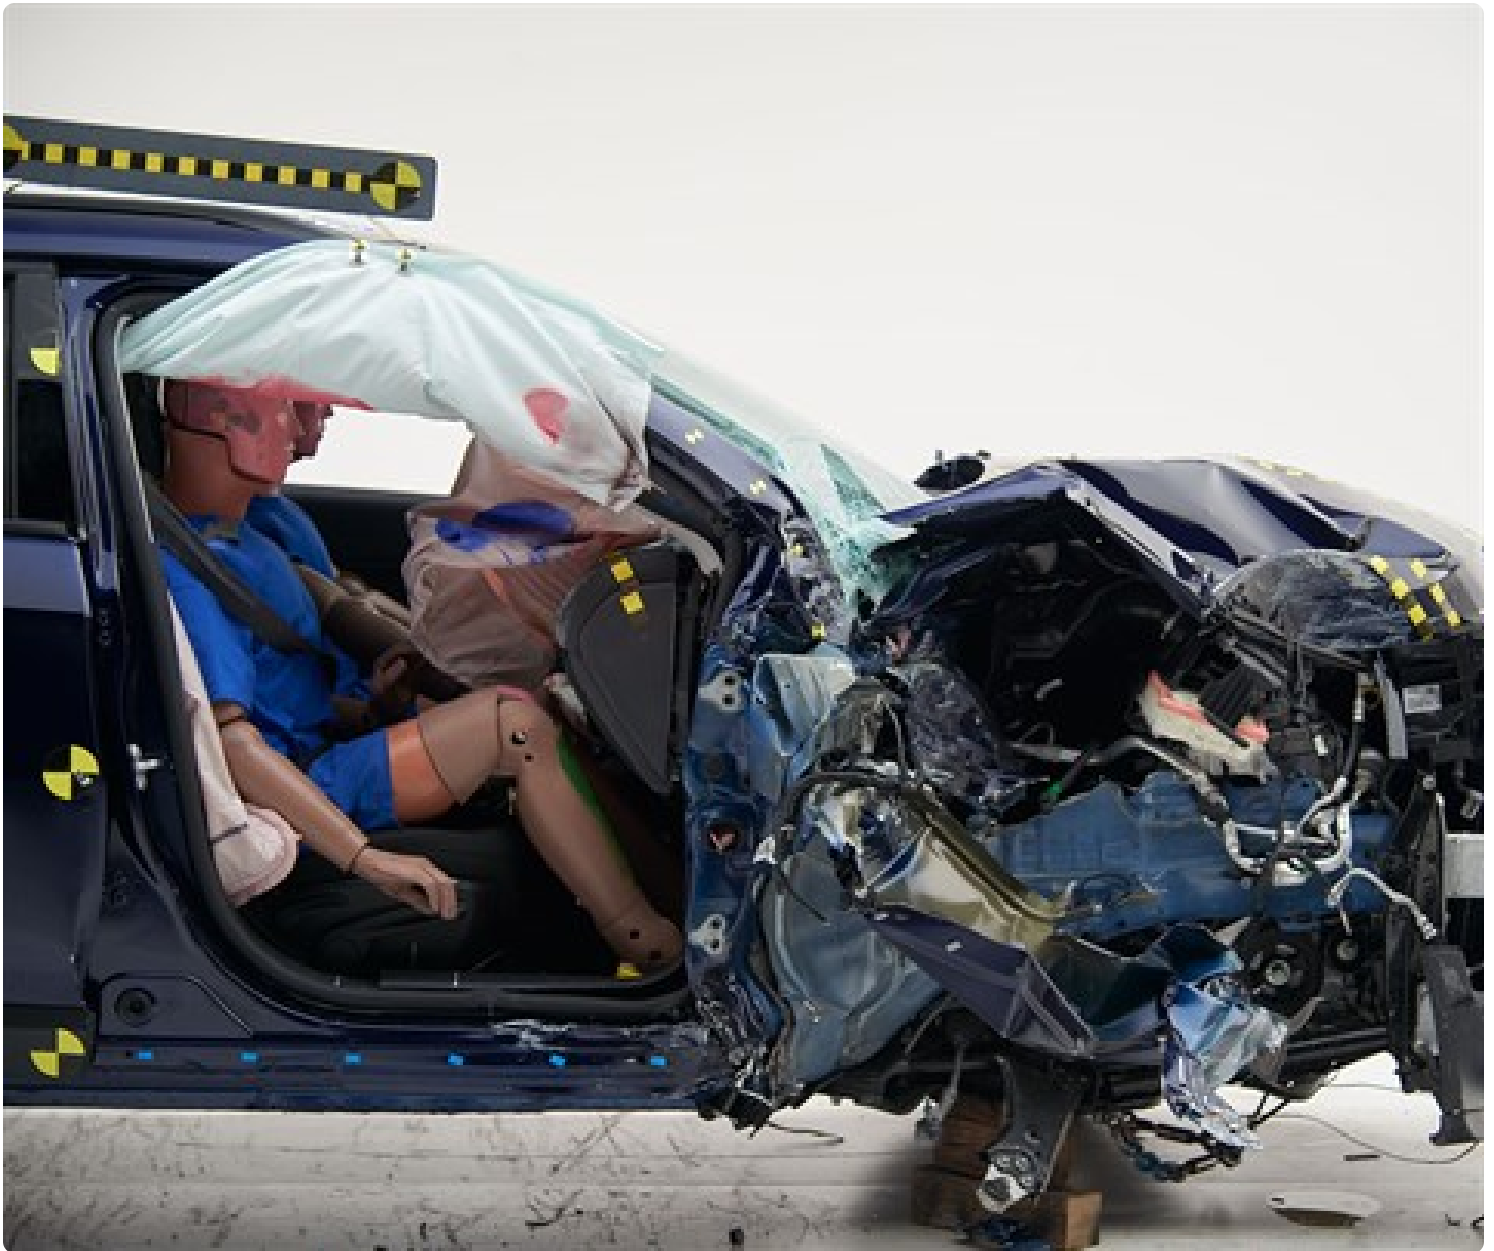
The dummy's position in relation to the door frame and dashboard after the crash test indicates that the passenger's survival space was maintained reasonably well.

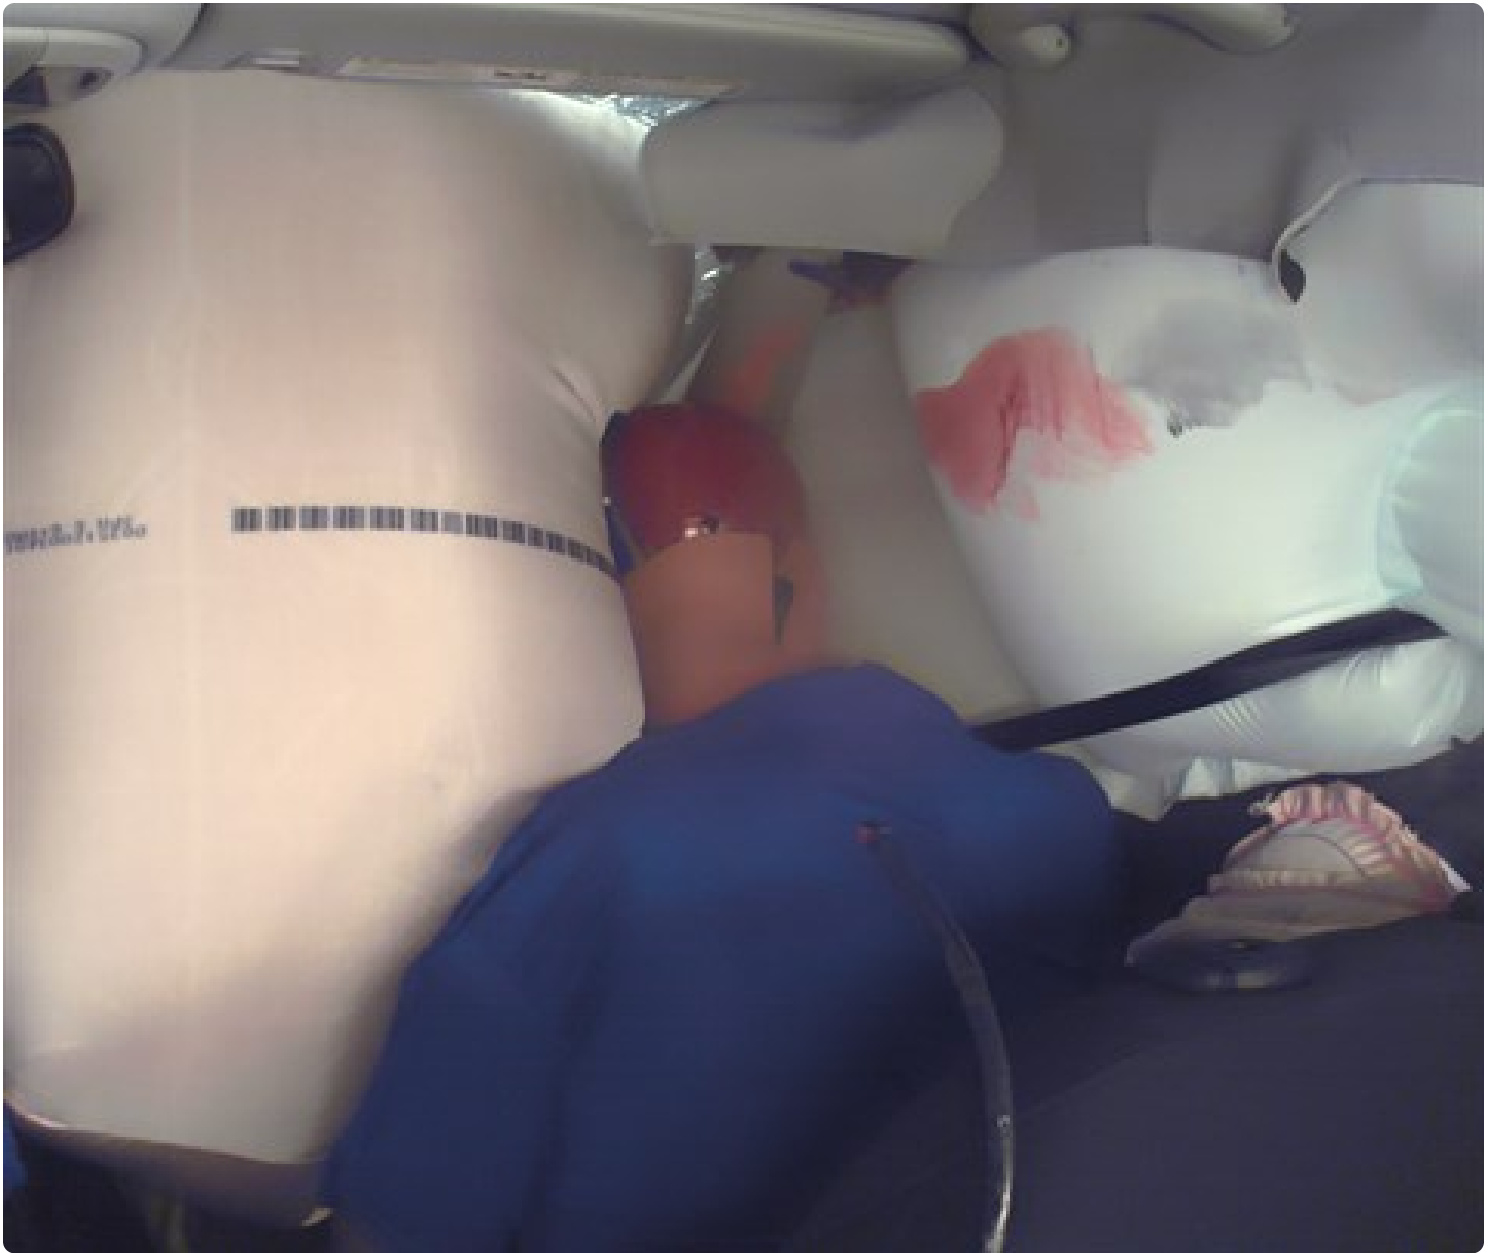
The frontal and side curtain airbags worked well together to keep the passenger dummy's head from coming close to any stiff structure or outside objects that could cause injury.

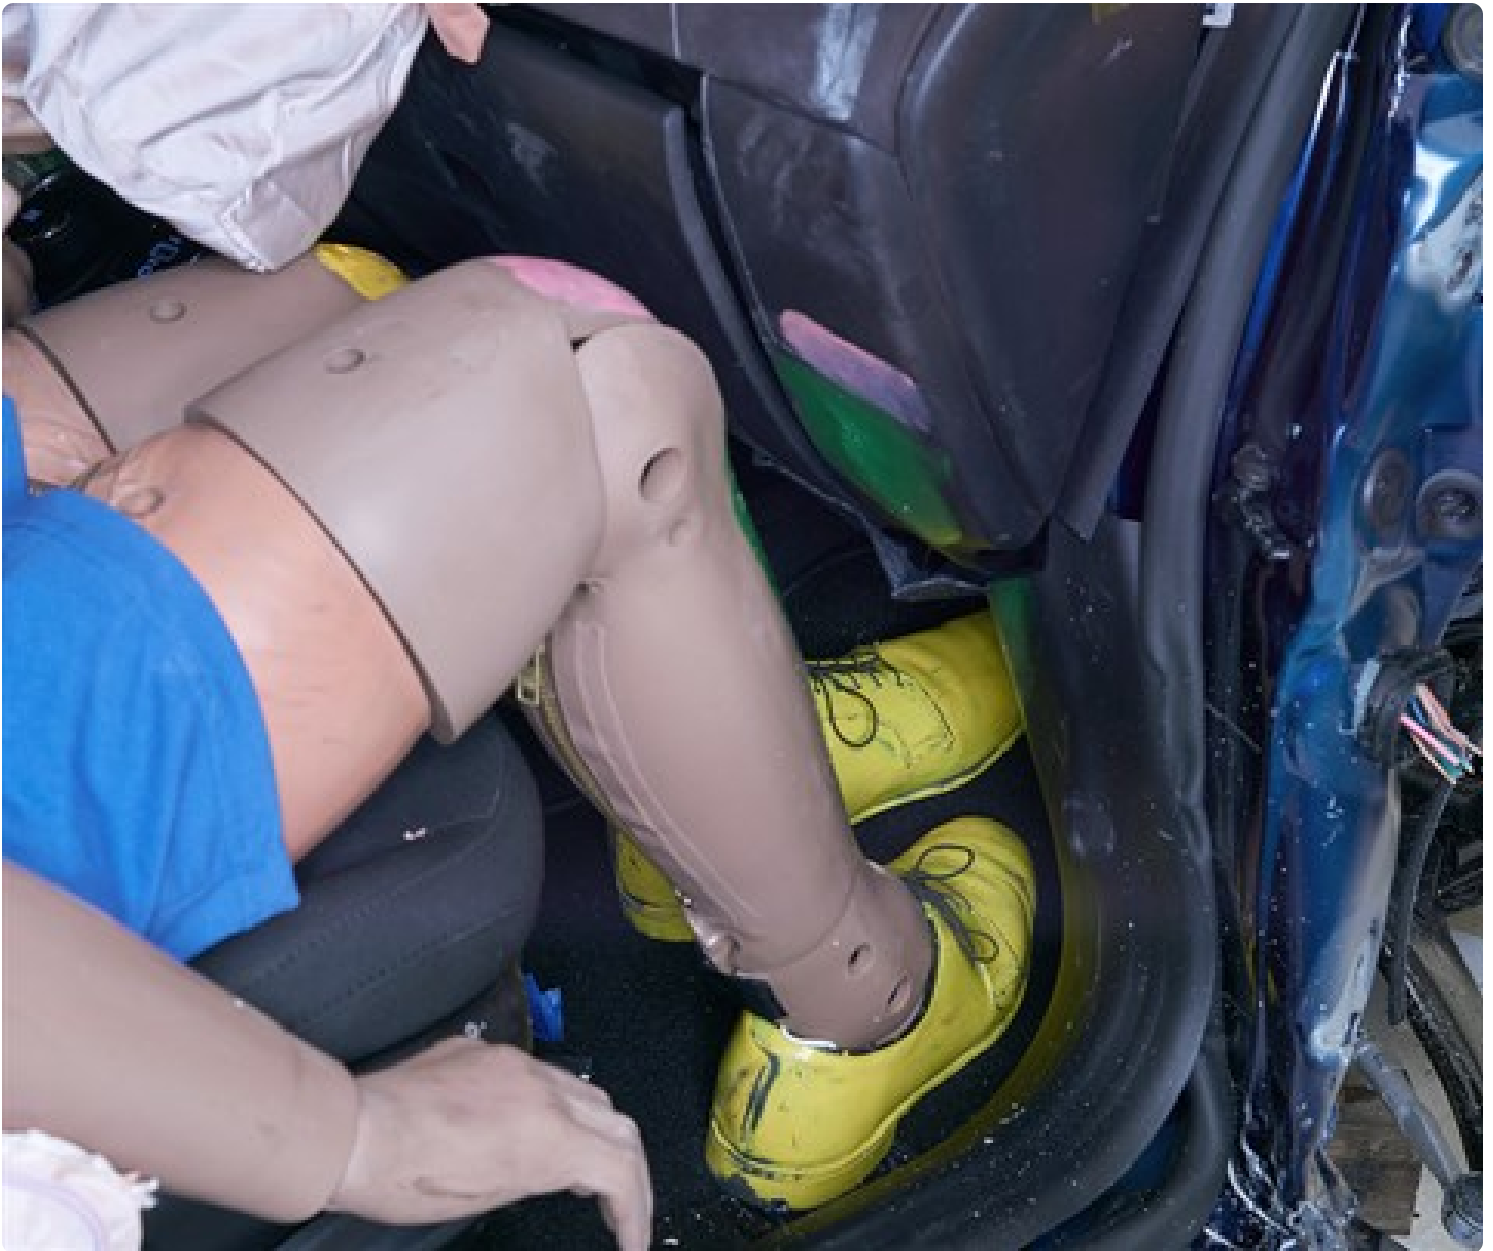
Intrusion of the dashboard contributed to a moderate risk of injury to the right lower leg.

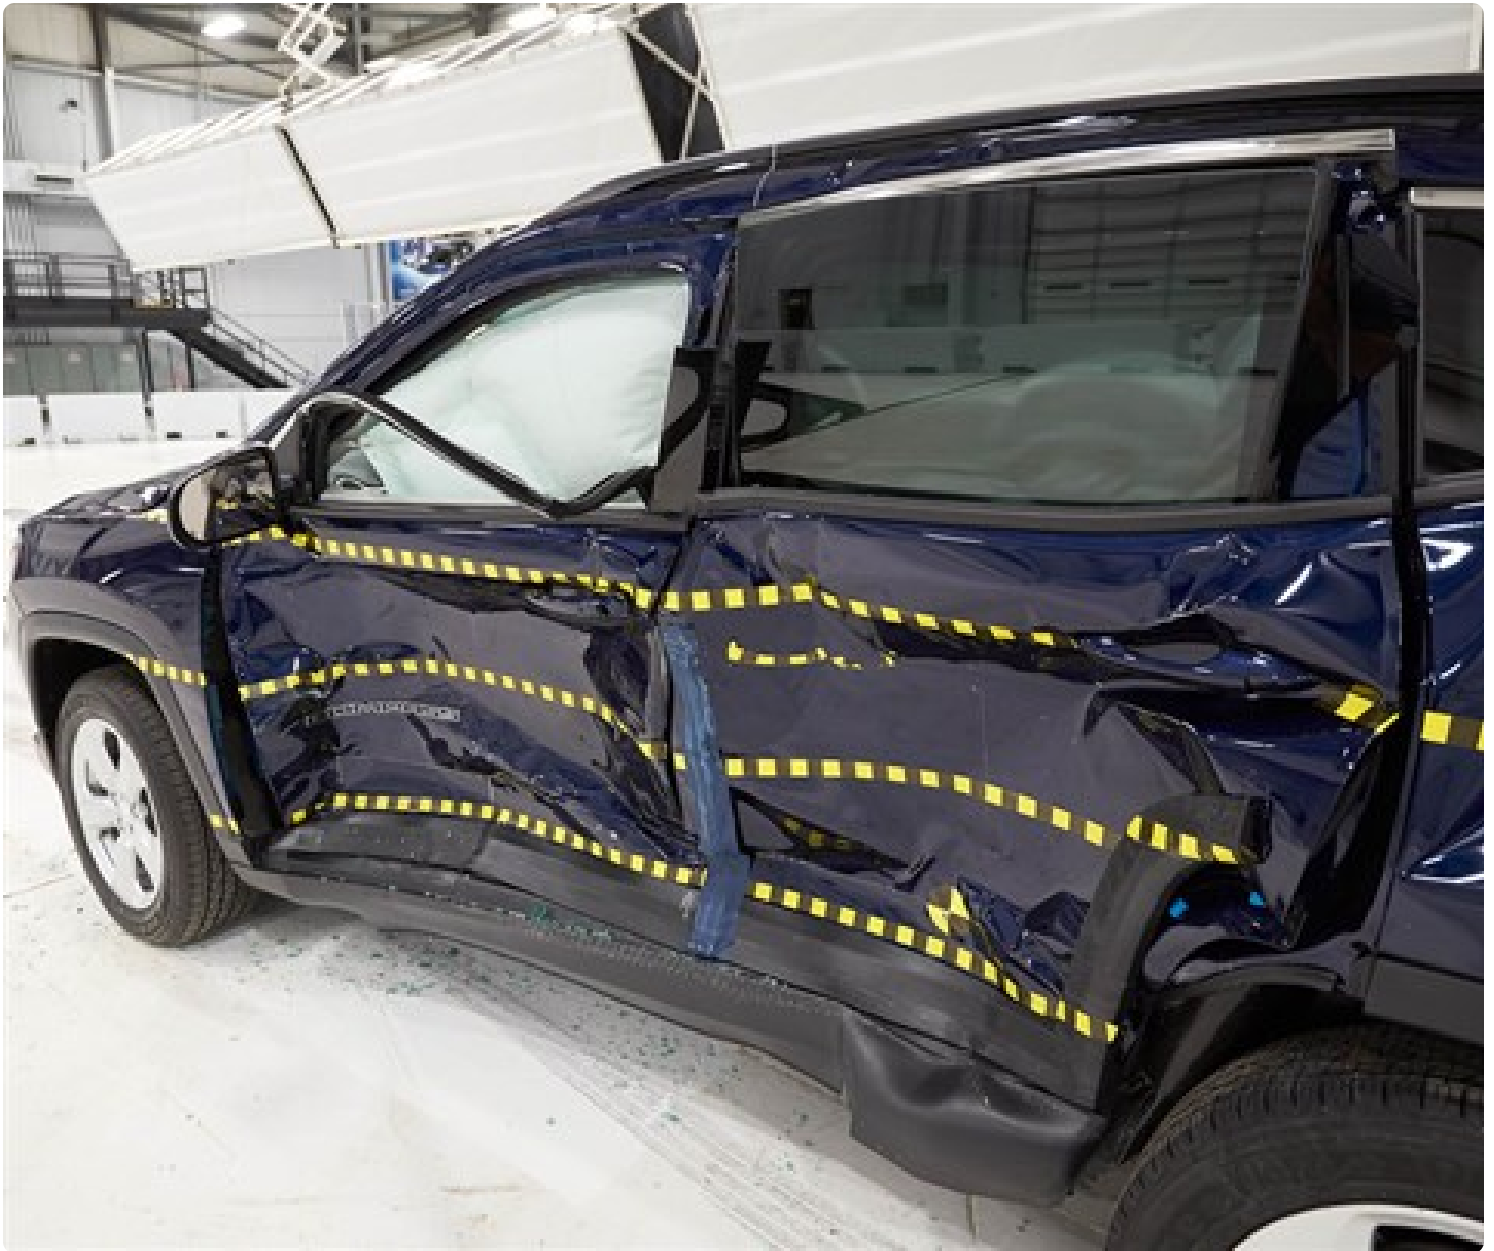
View of the vehicle just after the crash test.

Overall evaluation	M
Structure and safety cage	M
Driver injury measures	
Head/neck	G
Torso	A
Pelvis	P
Driver head protection	G
Rear passenger injury measures	
Head/neck	G
Torso	A
Pelvis	A
Rear passenger head protection	G

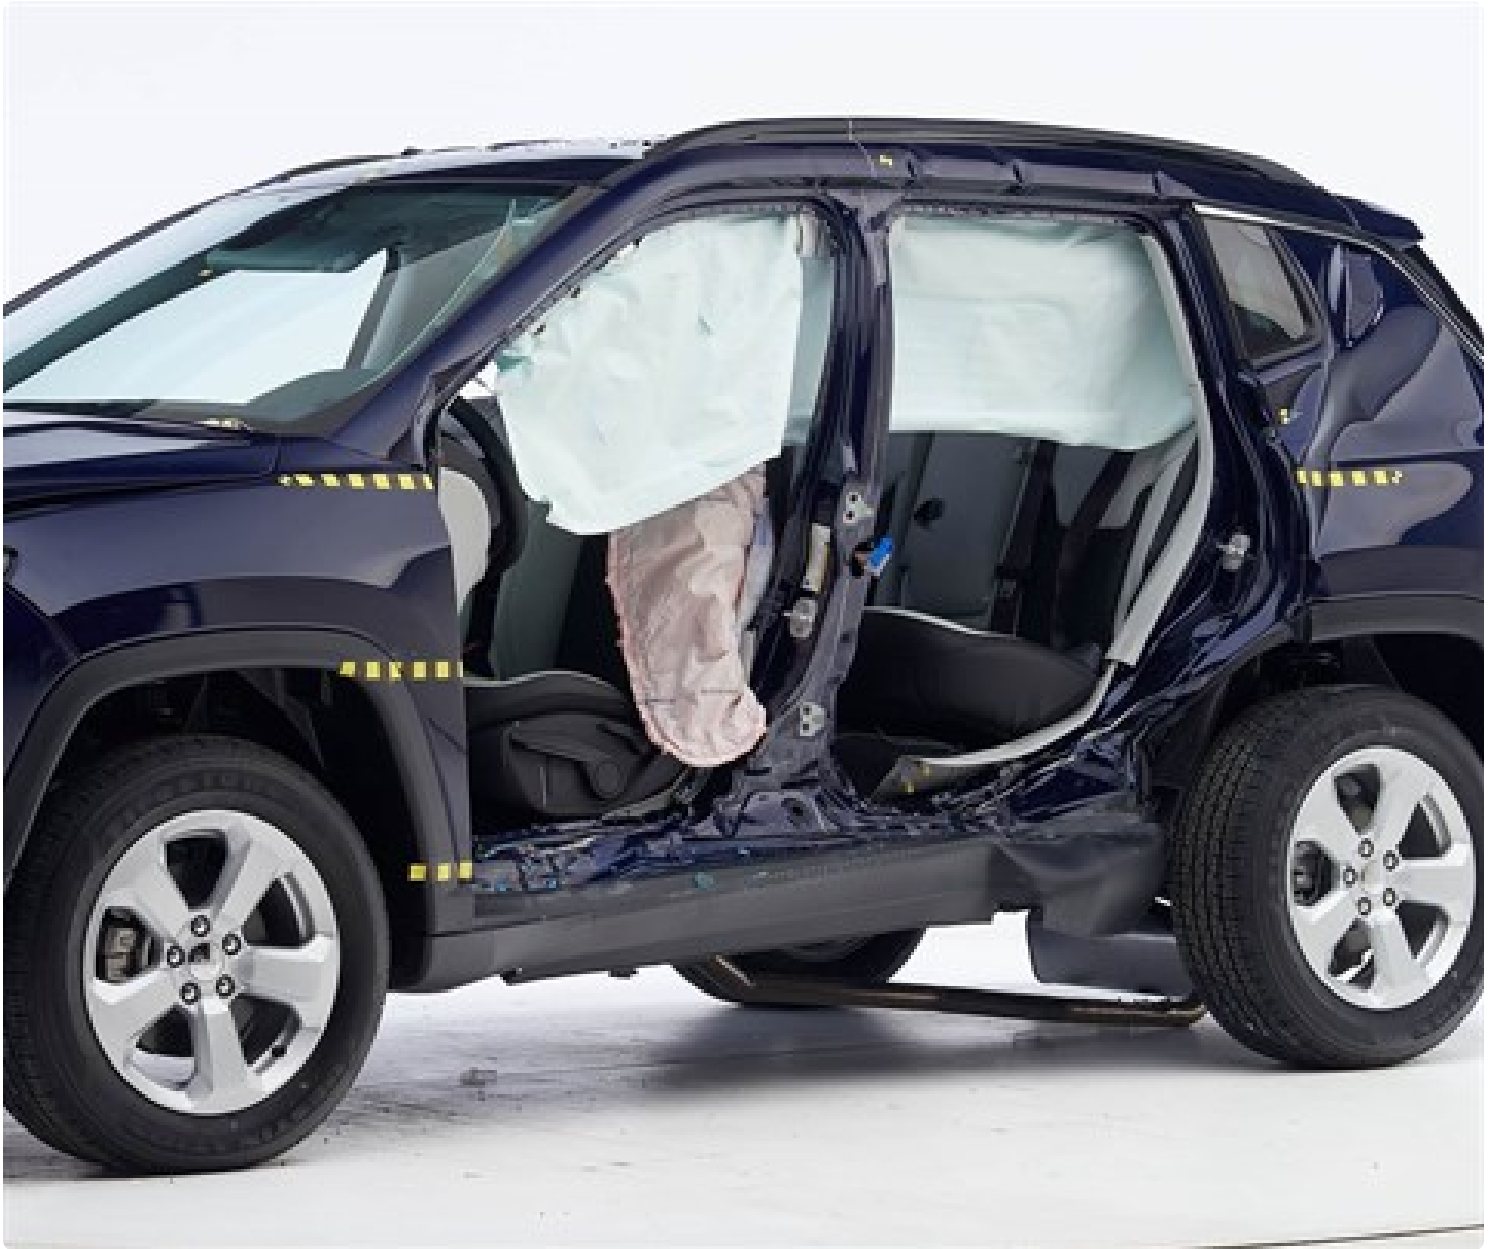
View of the vehicle after the crash with doors removed, showing the side airbags and damage to the occupant compartment.

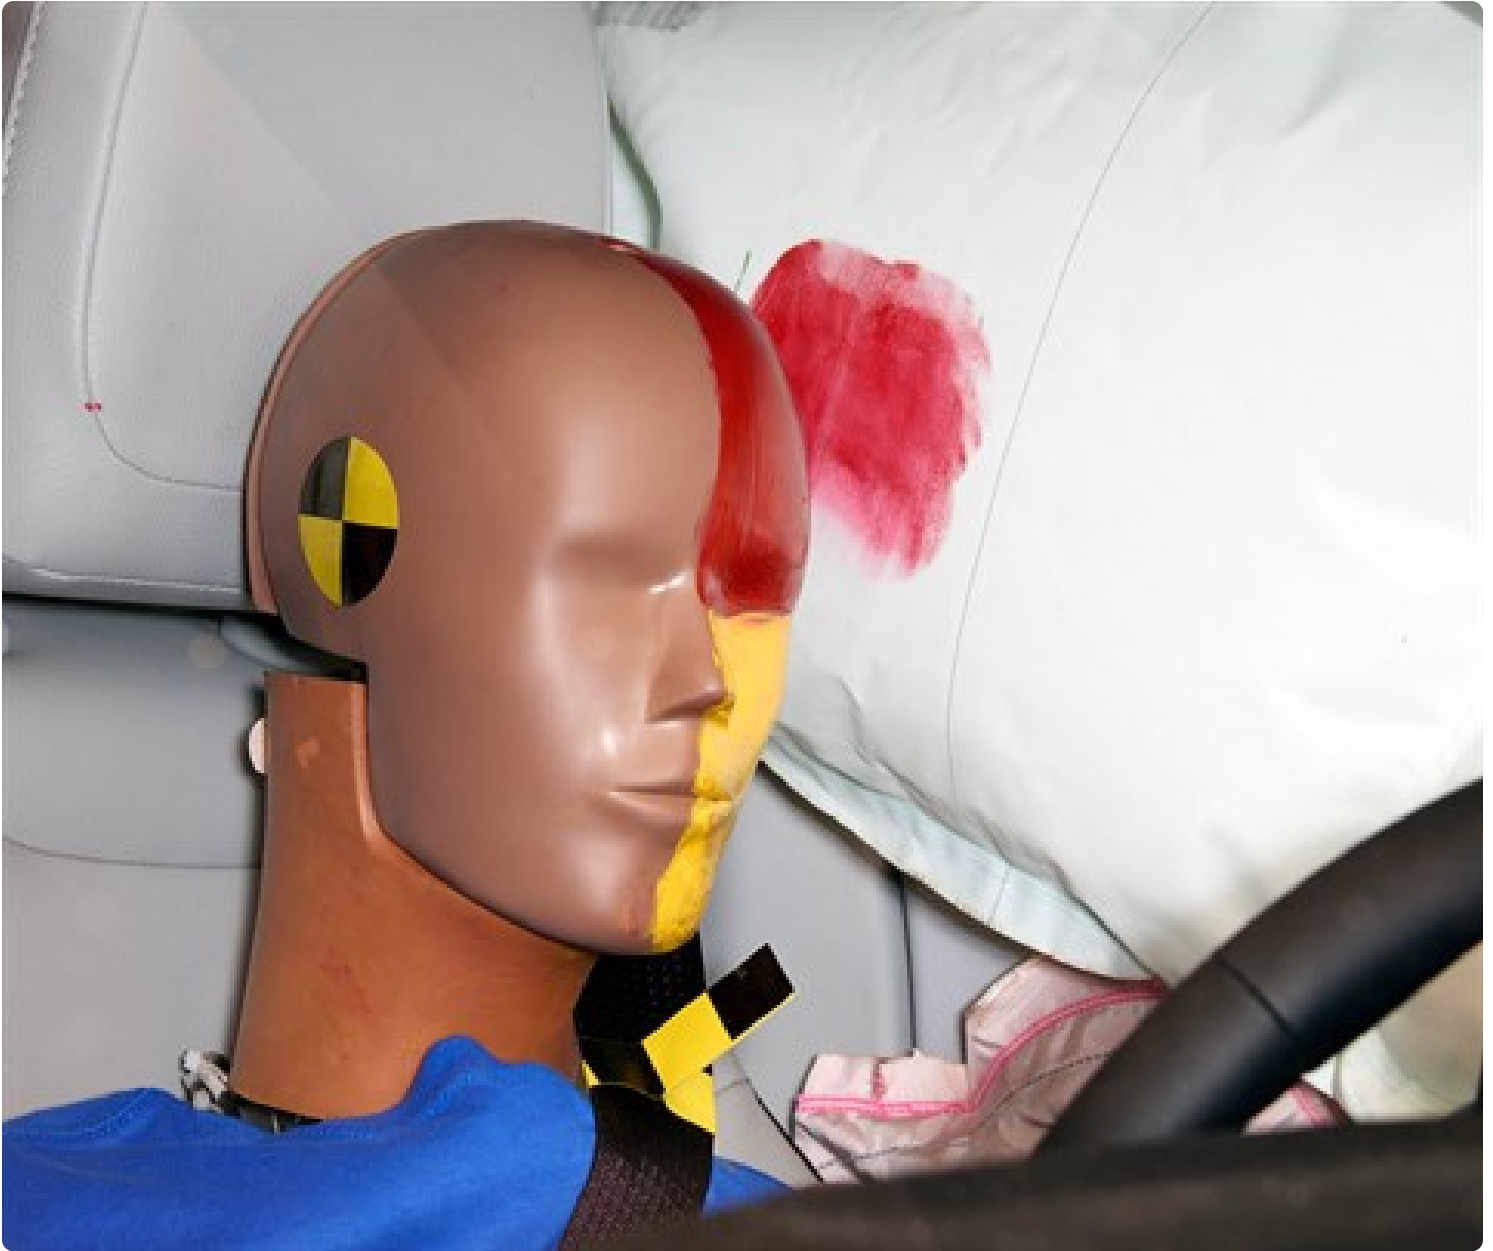
Smearred greasepaint shows where the driver dummy's head was protected from being hit by hard structures by the side airbags.

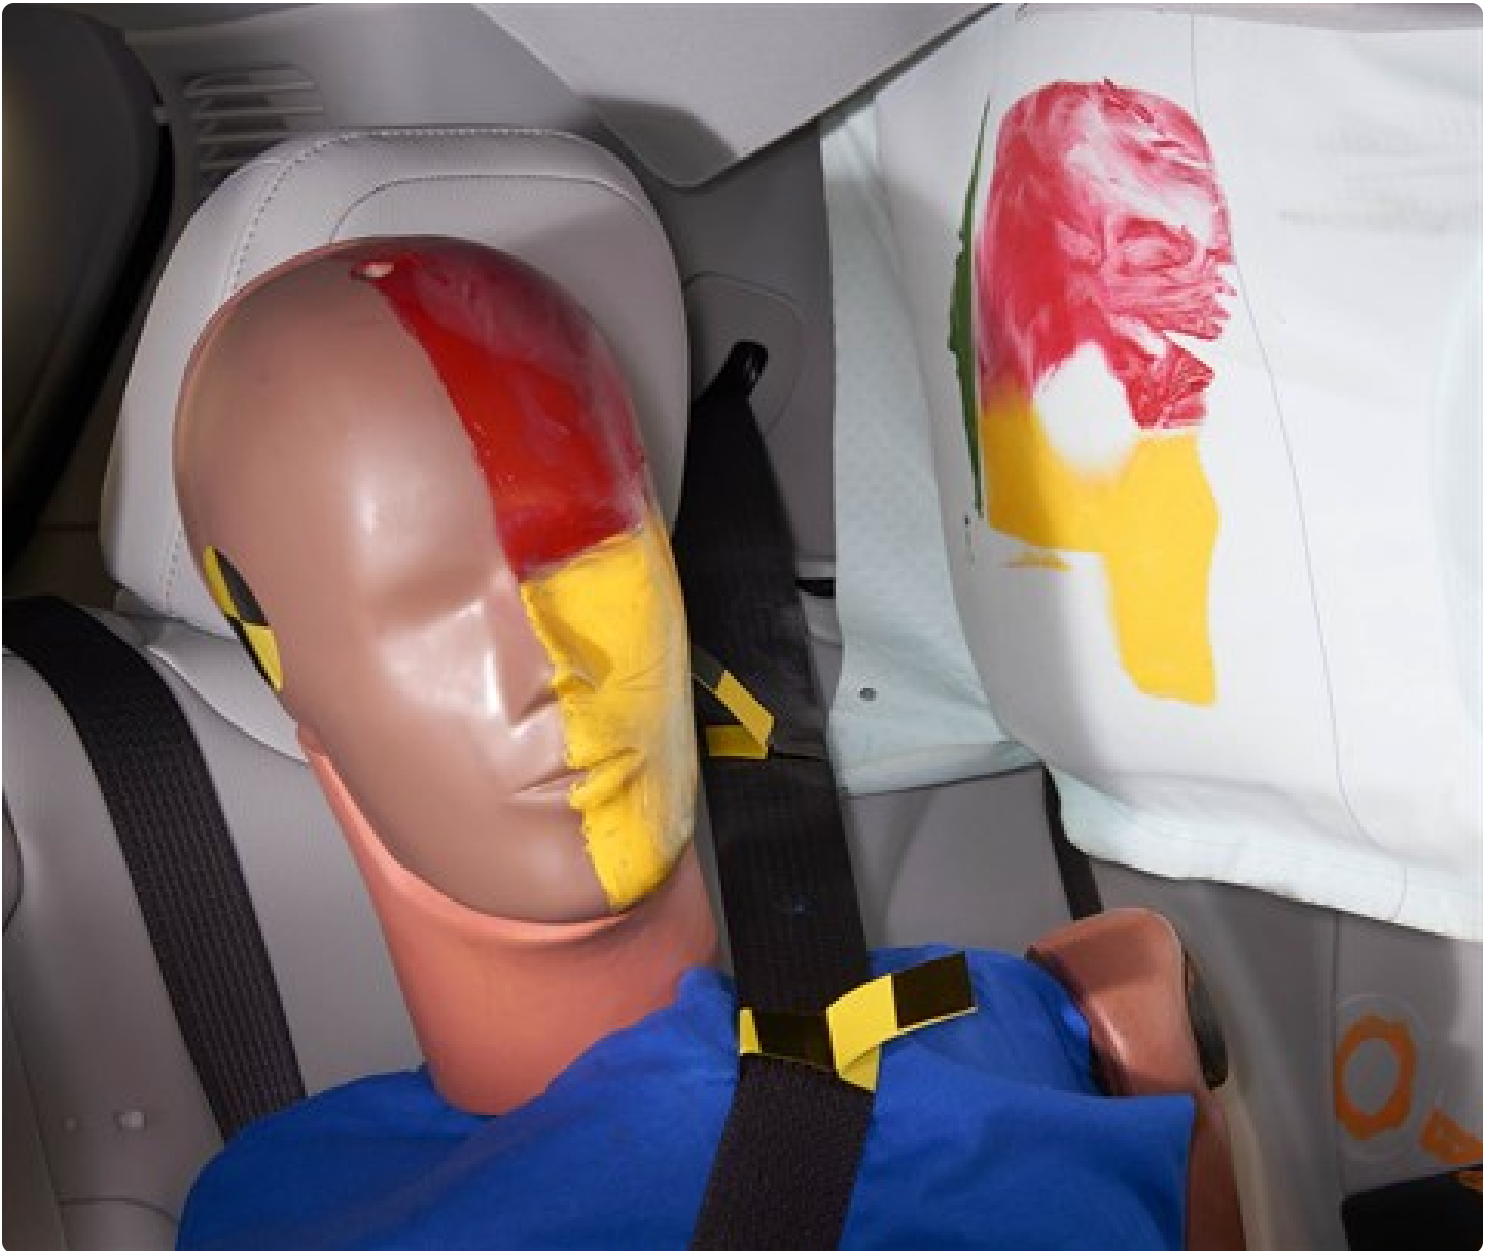
Smeared greasepaint shows where the rear passenger dummy's head was protected by the side airbag.
