2019 Jeep Compass Latitude

Odometer: 66,882
Engine: 2.4L I4 MultiAir
Color: Granite Crystal Metallic Clearcoat
Interior: Black Cloth

Transmission: 6-Speed Aisin Automatic
VIN: 3C4NJCBB8KT676592
Stock #: 1C261970AV
Drivetrain: FWD

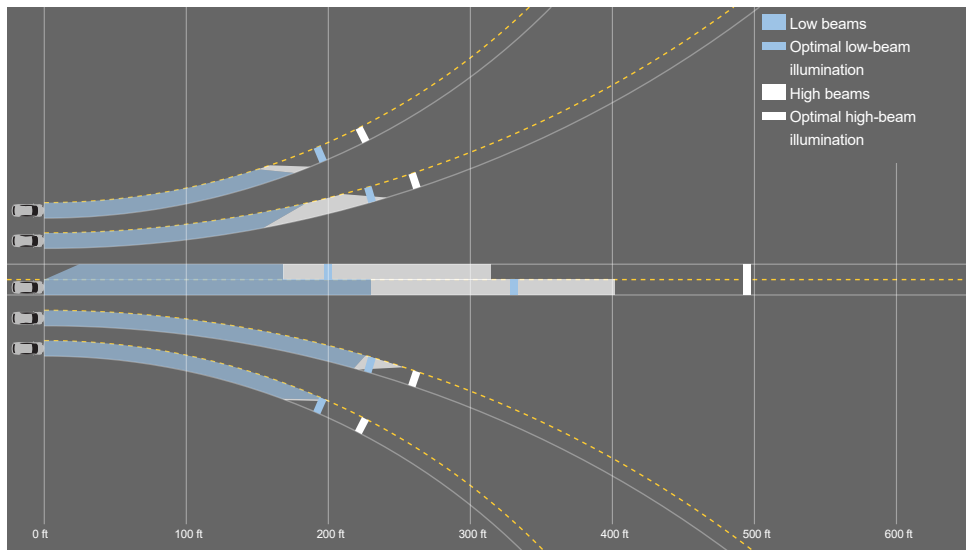
Distance at which headlights provide at least 5 lux illumination:

On the straightaway, visibility was fair on the left side of the road and inadequate on the right side. On curves, visibility was good on the gradual right curve, fair on the sharp right and sharp left curves, and inadequate on the gradual left curve.

On the straightaway, visibility was inadequate on both sides of the road. On curves, visibility was fair on the gradual right and gradual left curves and inadequate on the sharp right and sharp left curves.

Low-beam headlight type	HID projector
High-beam headlight type	HID projector
Curve-adaptive?	No
High-beam assist?	Yes
Overall rating	M

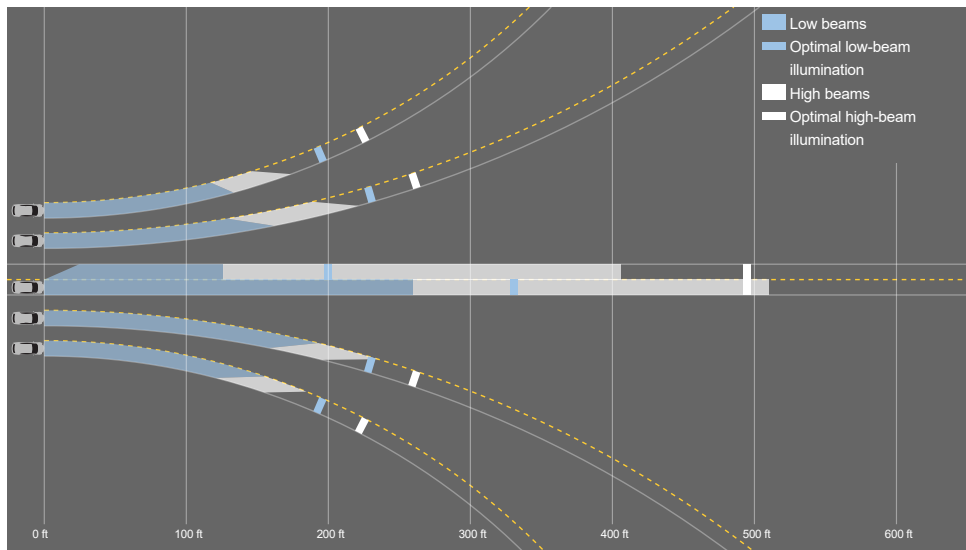
Distance at which headlights provide at least 5 lux illumination:

On the straightaway, visibility was fair on the right side of the road and inadequate on the left side. On curves, visibility was inadequate in all 4 tests.

On the straightaway, visibility was good on the right side of the road and inadequate on the left side. On curves, visibility was inadequate in all 4 tests.

Overall rating **P**

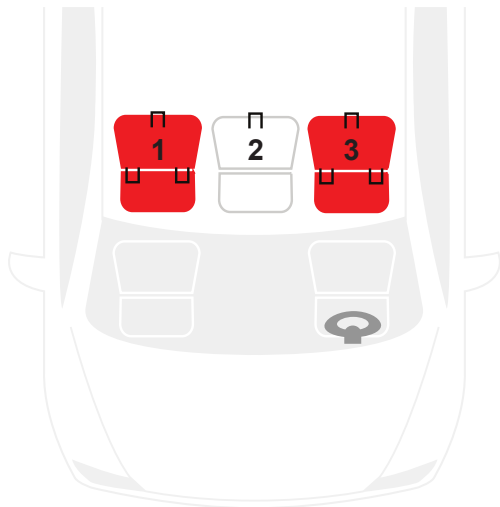
This vehicle has 2 rear seating positions with complete child seat attachment (LATCH) hardware. It has 1 additional seating position with a tether anchor only.

- 1 Tether anchor**
 - easy-to-find location
 - no other hardware could be confused for anchor
- Lower anchors**
 - too deep in seat
 - too much force needed to attach
 - difficult to maneuver around anchors
- 2 Tether anchor**
 - easy-to-find location
 - no other hardware could be confused for anchor
- Lower anchors**
 - none available
- 3 Tether anchor**

Overall evaluation	P
Vehicle trim	Latitude
Seat type	leatherette
