## 2018 Chevrolet Equinox LT

# Experian AutoCheck Report

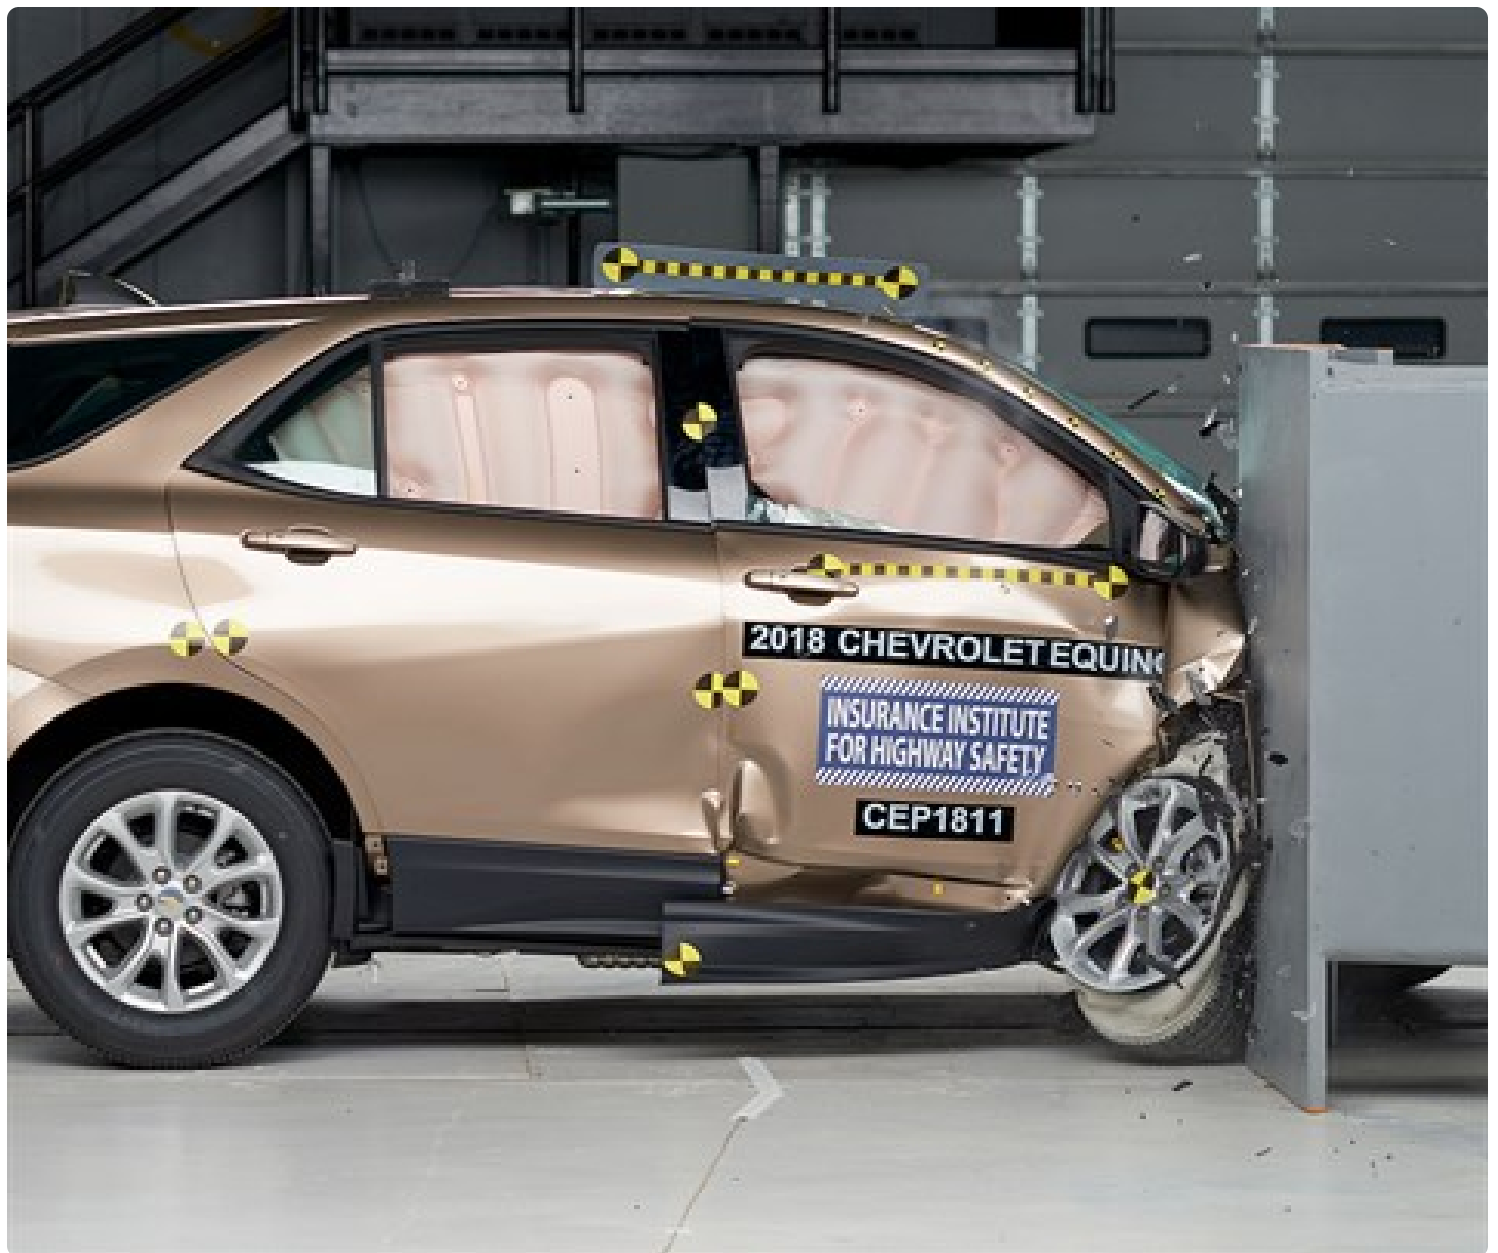
Action shot taken during the passenger-side small overlap frontal crash test.

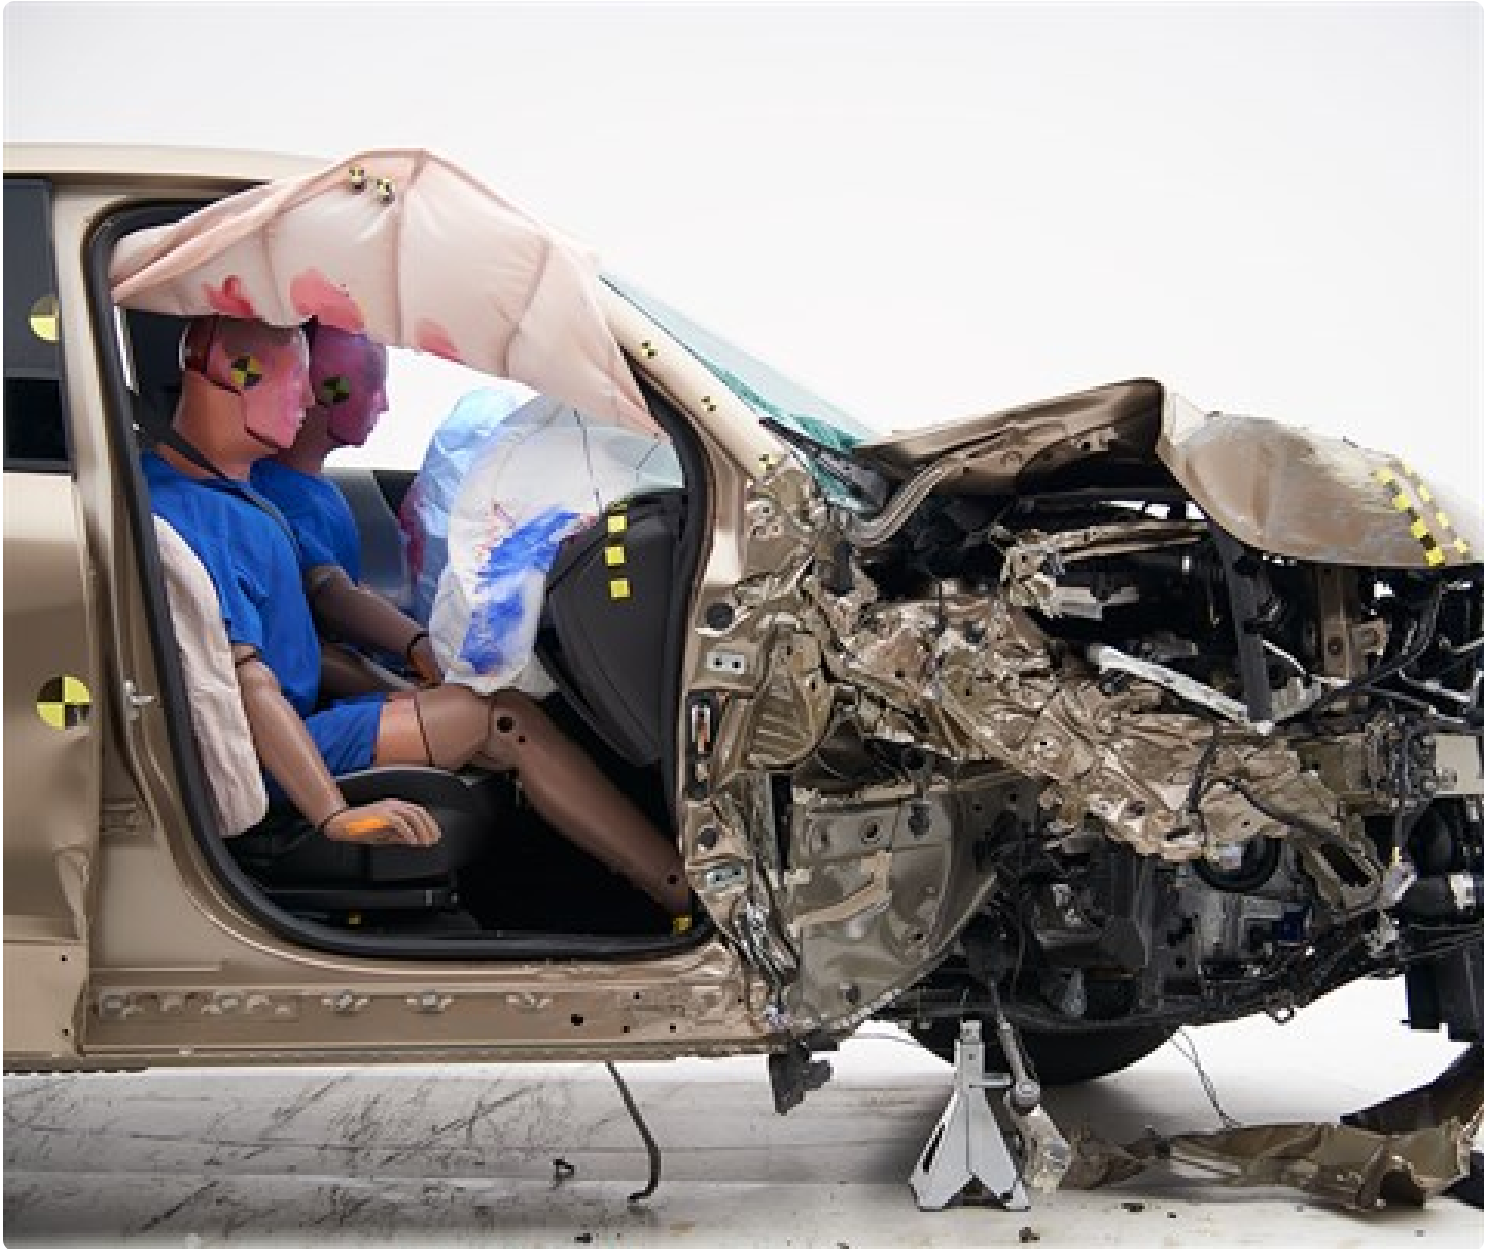
The dummy's position in relation to the door frame and dashboard after the crash test indicates that the passenger's survival space was maintained reasonably well.

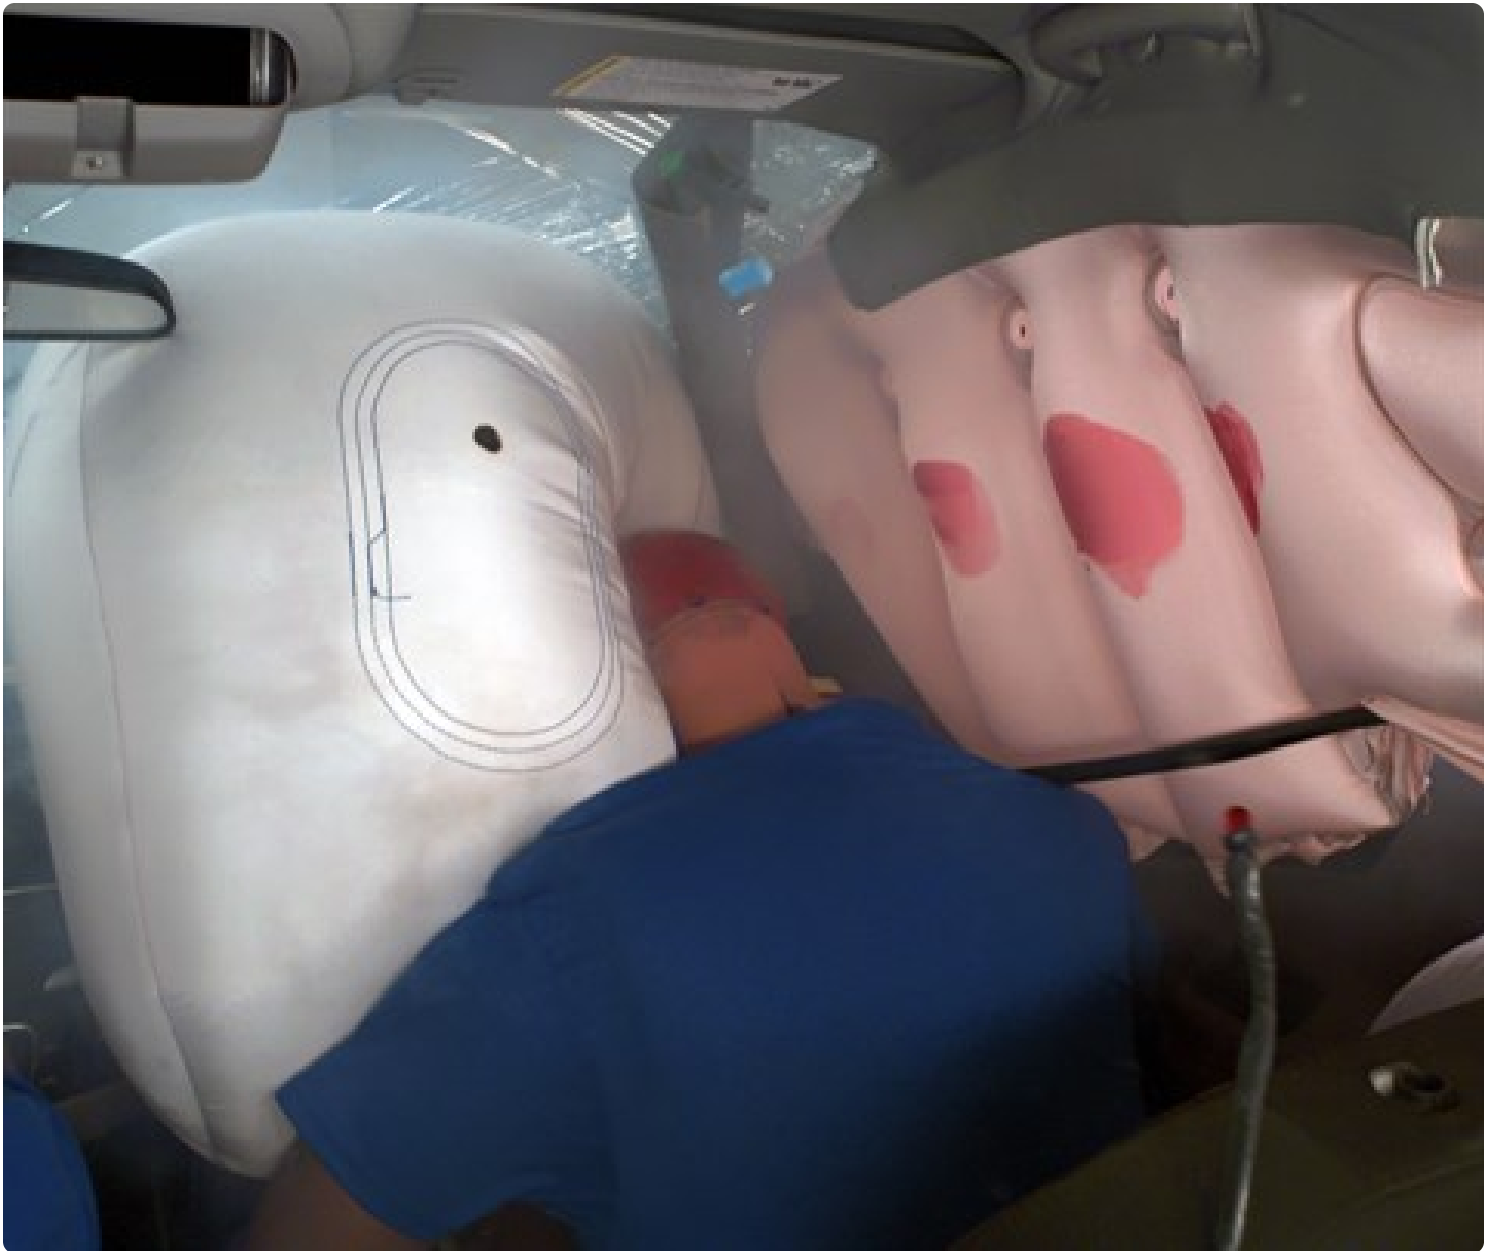
The frontal and side curtain airbags worked well together to keep the passenger dummy's head from coming close to any stiff structure or outside objects that could cause injury.

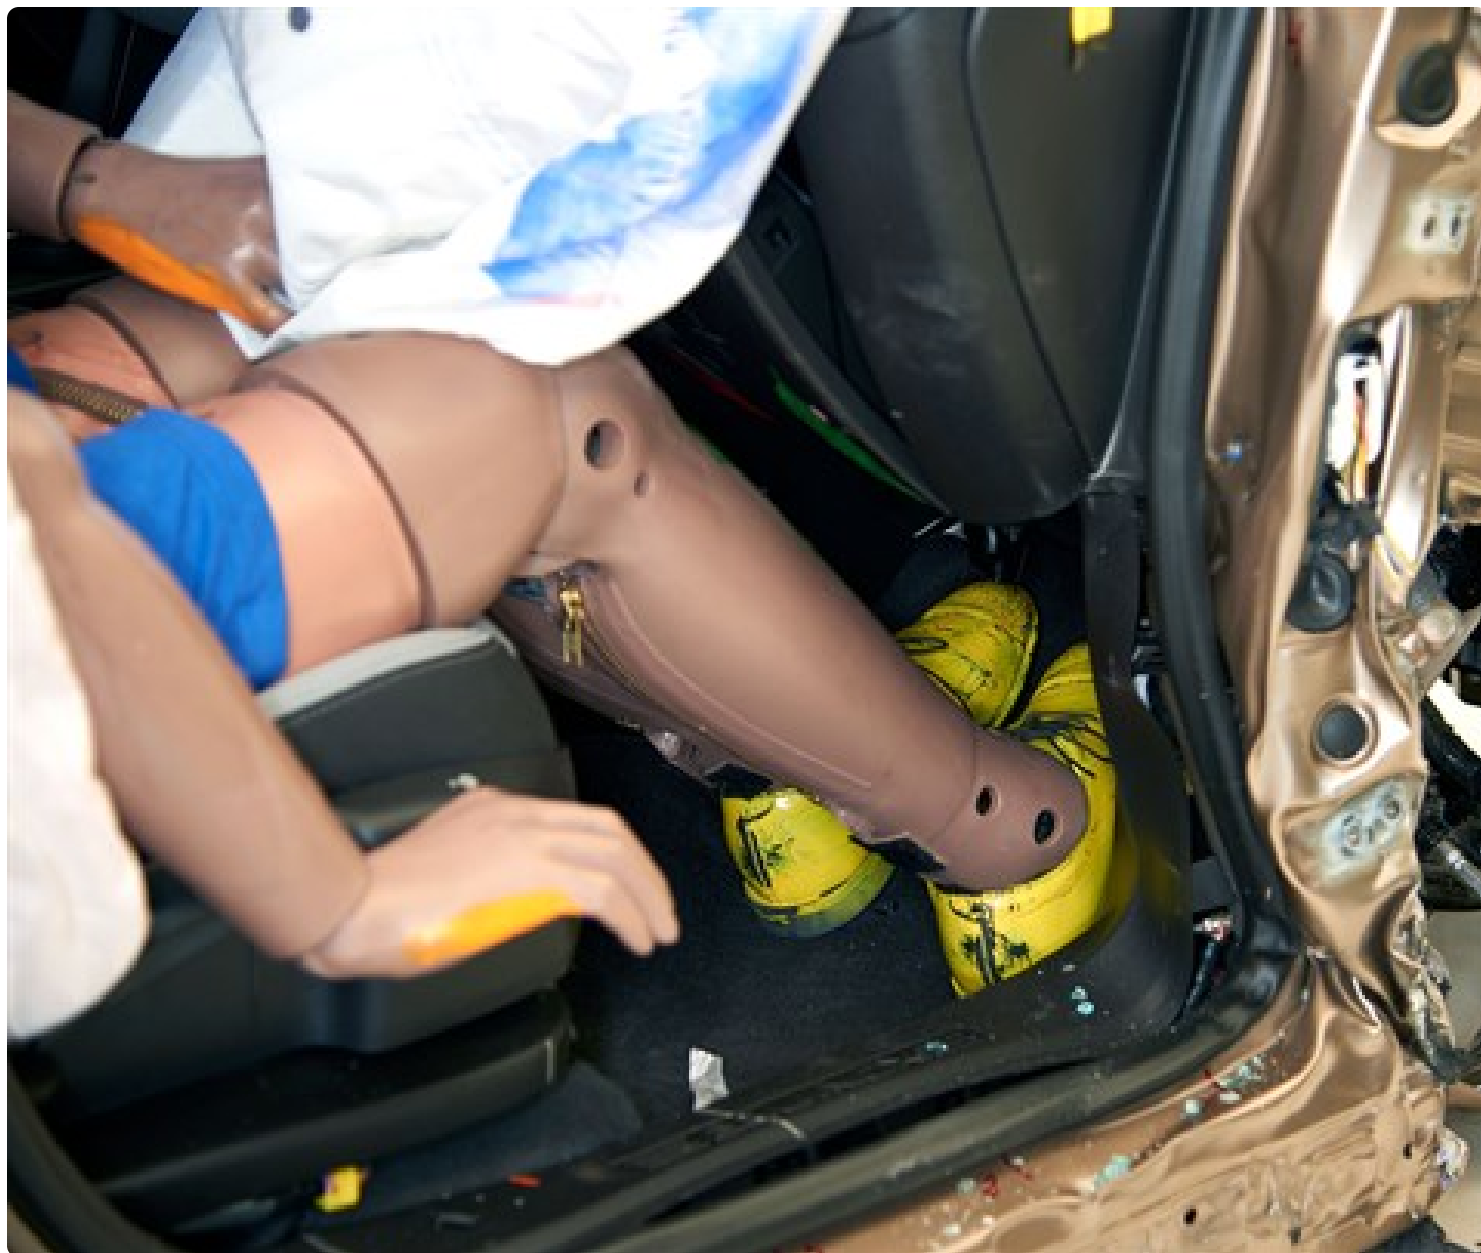
Intrusion of the dashboard and door hinge pillar contributed to a moderate risk of injury to the right lower leg.

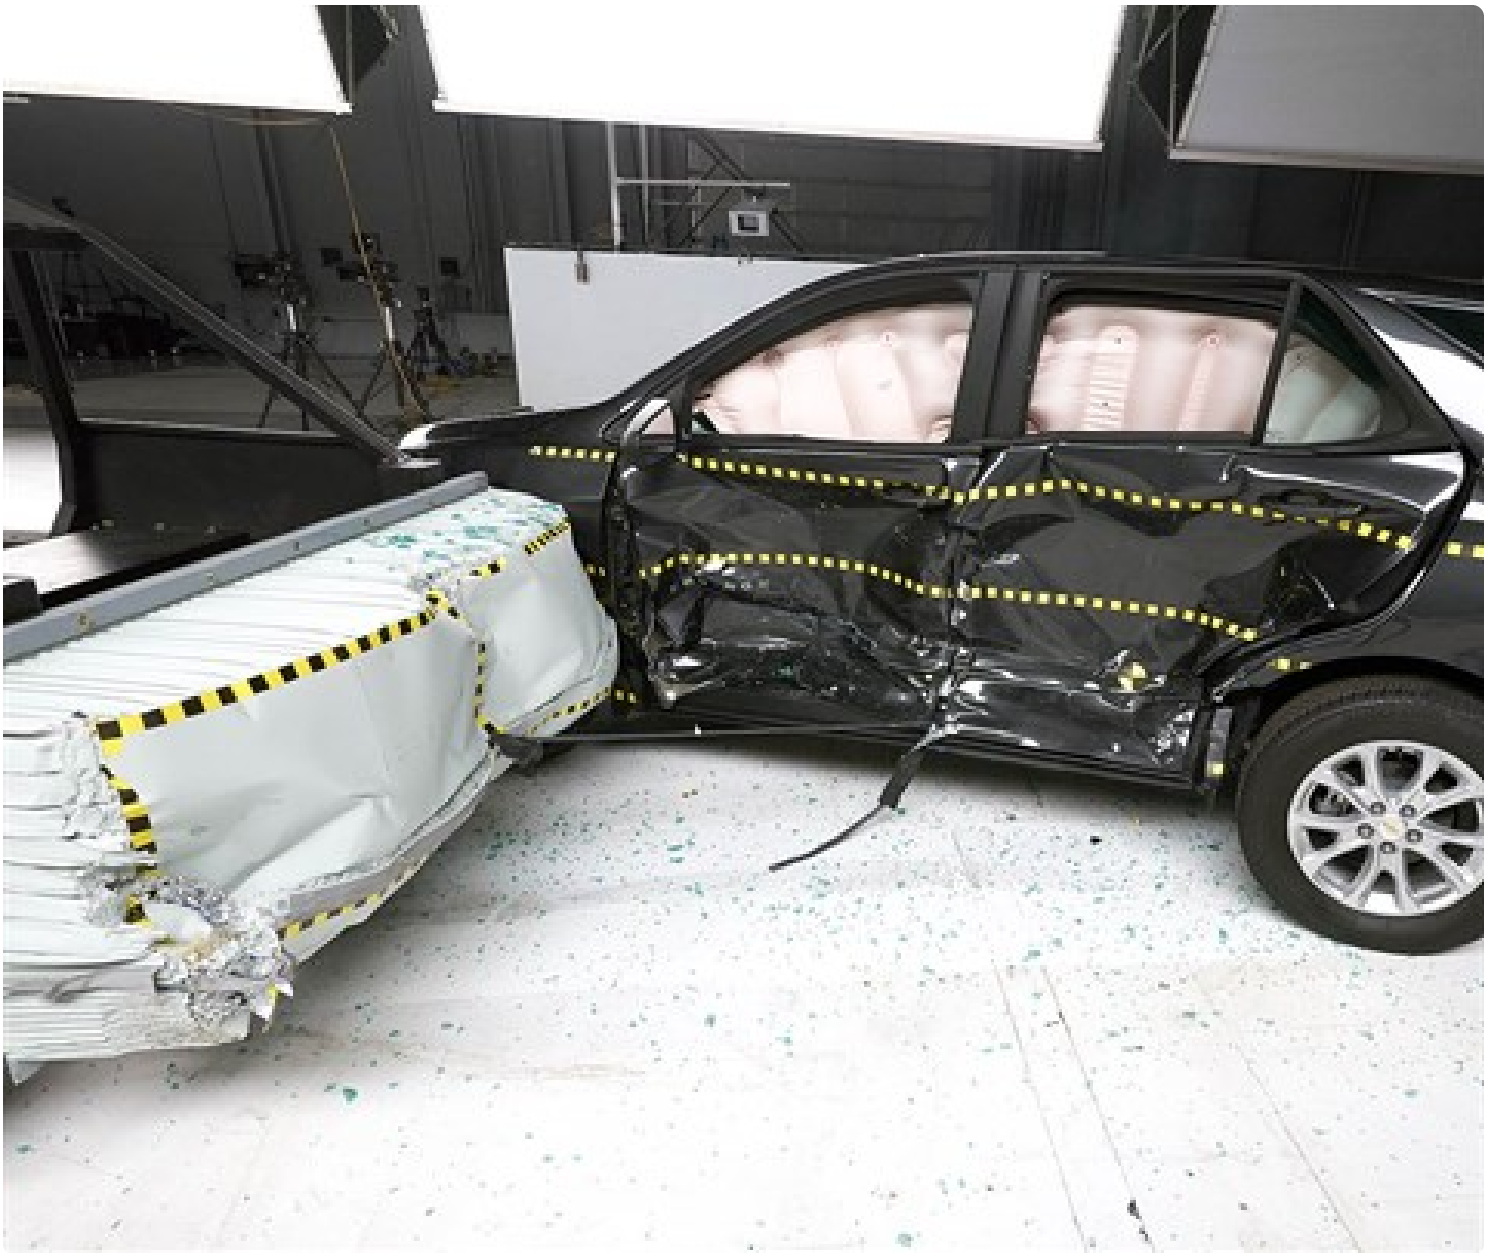
View of the vehicle just after the crash test.

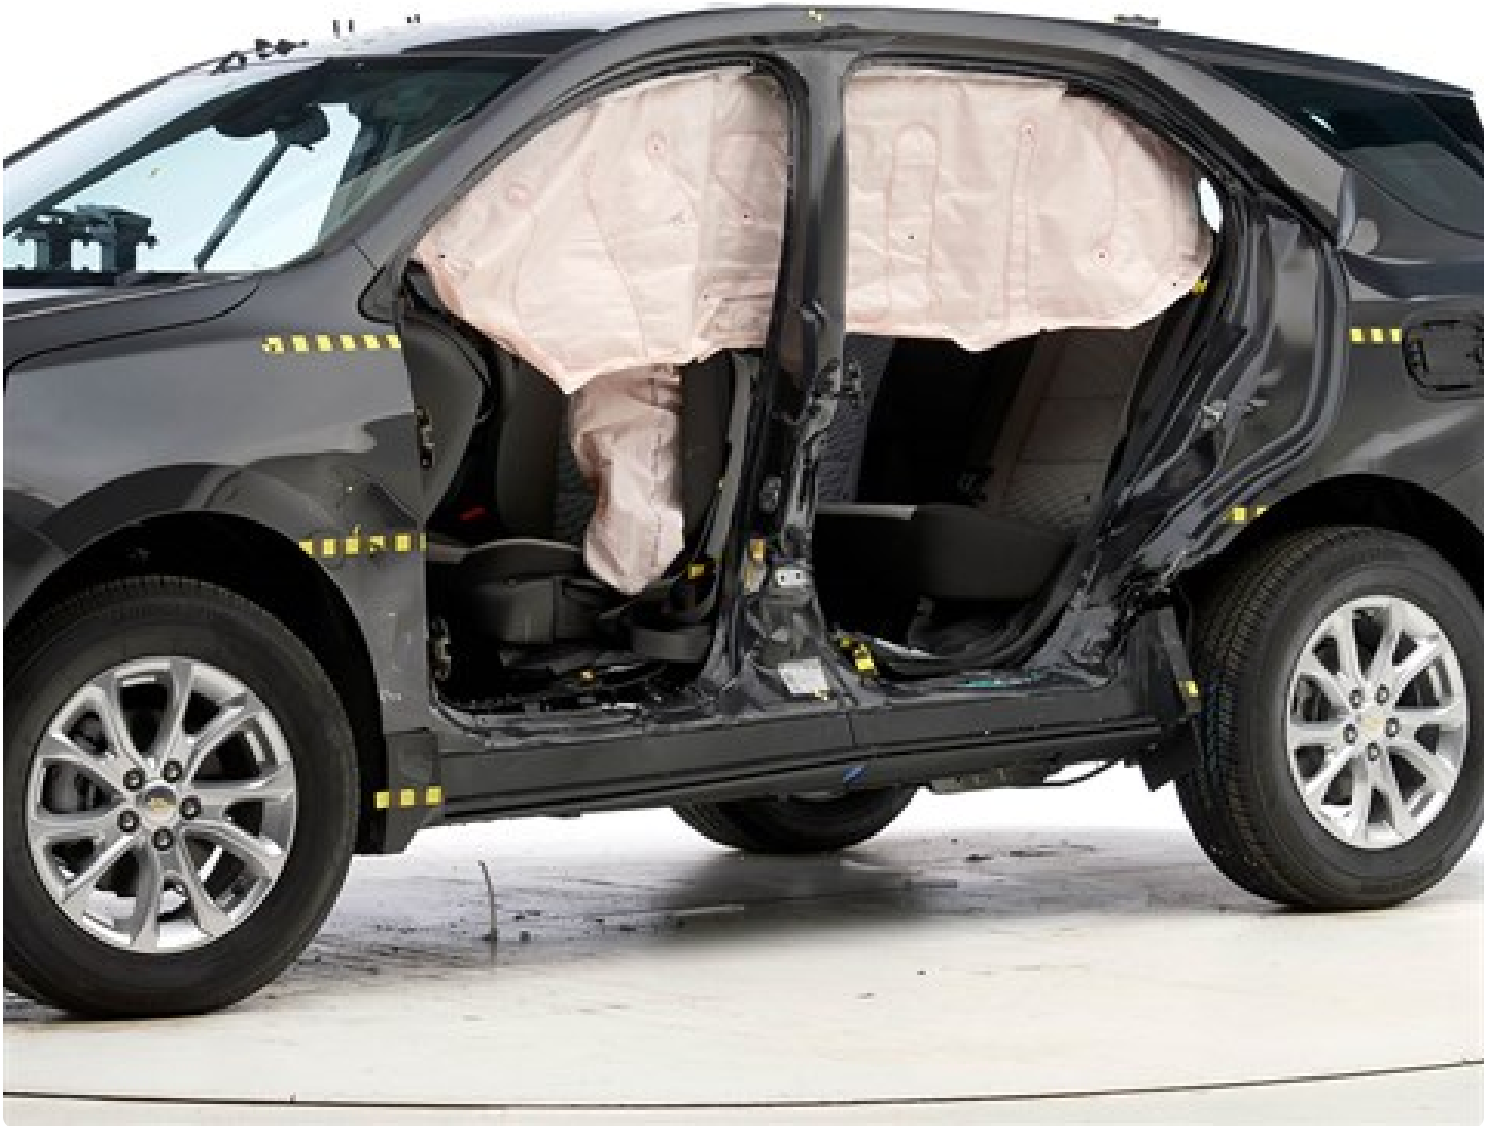
View of the vehicle after the crash with doors removed, showing the side airbags and damage to the occupant compartment.

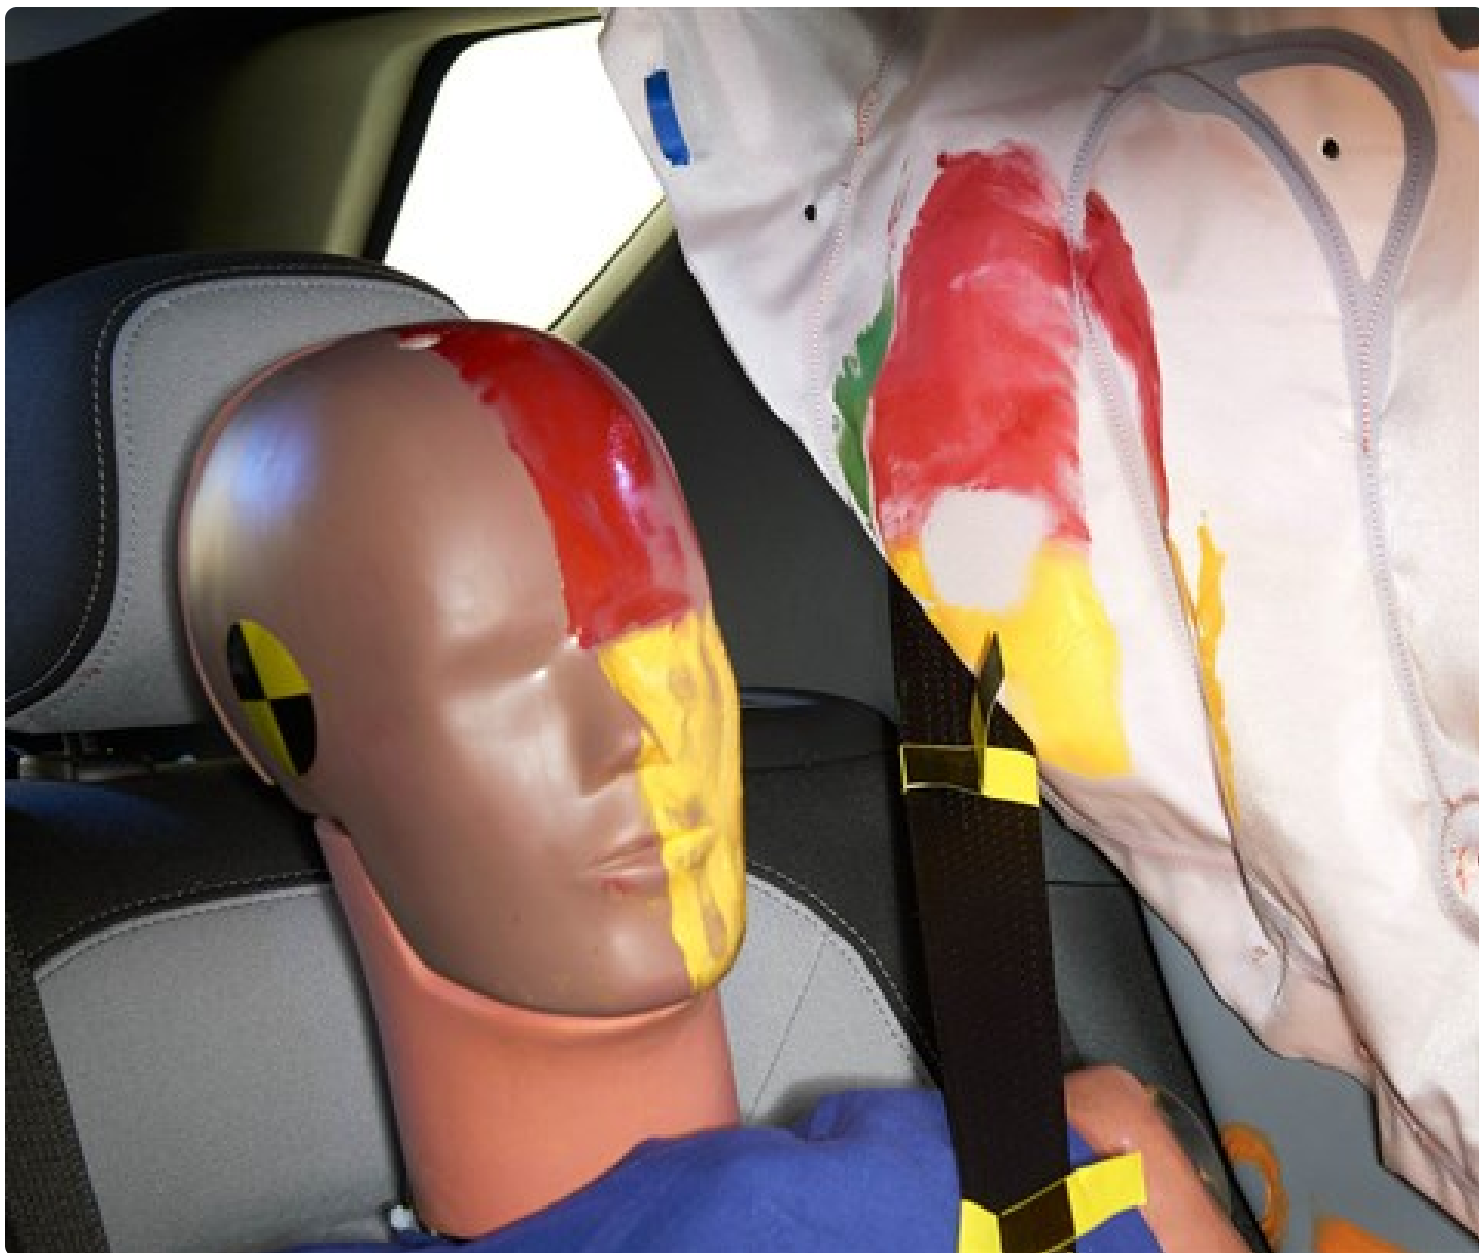
The dummy's head contacted the C-pillar hard, through the side curtain airbag. The head protection is inadequate.

The dummy's head contacted the C-pillar through the side curtain airbag.

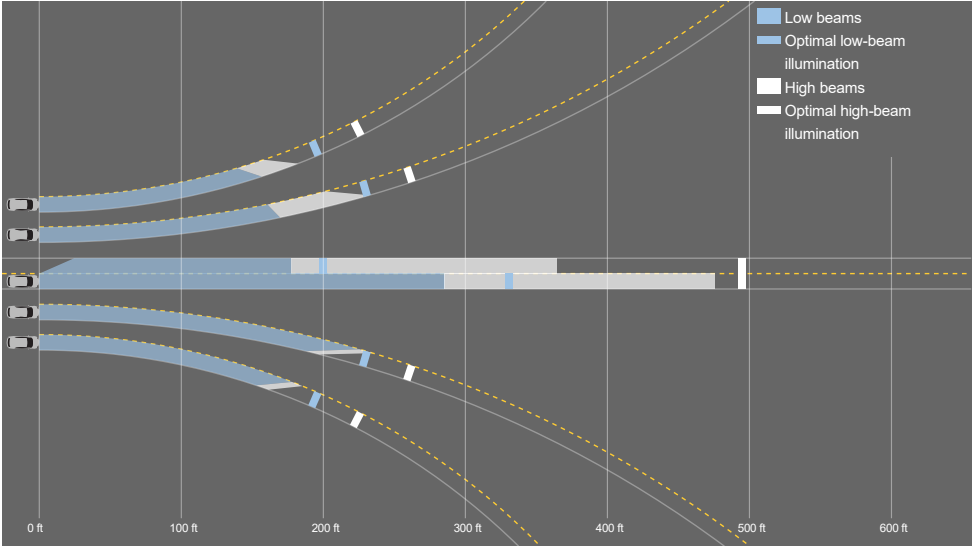
Distance at which headlights provide at least 5 lux illumination:

On the straightaway, visibility was fair on both sides of the road. On curves, visibility was fair on both right curves and inadequate on both left curves.

On the straightaway, visibility was good on the right side of the road and inadequate on the left side. On curves, visibility was inadequate in all 4 tests.

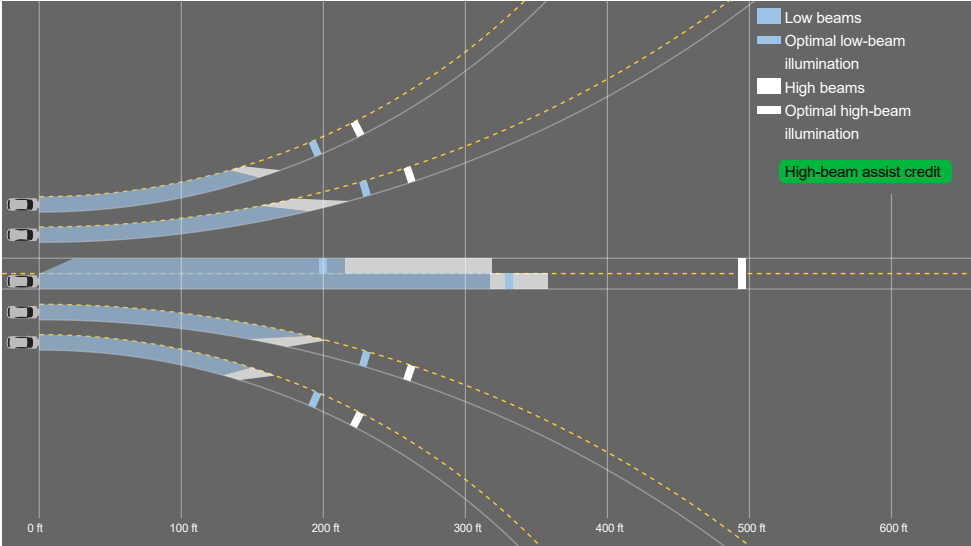
**Distance at which headlights provide at least 5 lux illumination:**

On the straightaway, visibility was good on both sides of the road. On curves, visibility was inadequate in all 4 tests.

On the straightaway, visibility was inadequate on both sides of the road. On curves, visibility was inadequate in all 4 tests.

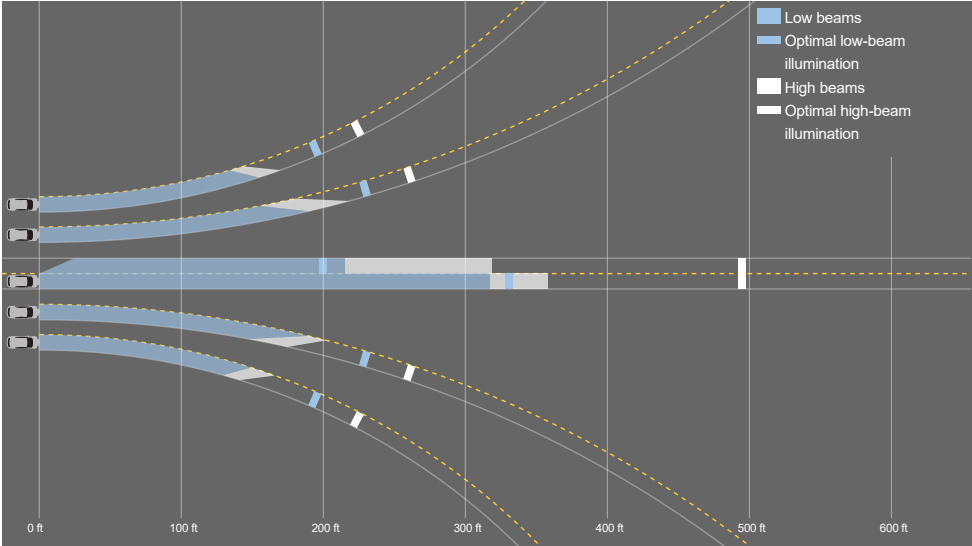
Distance at which headlights provide at least 5 lux illumination:

On the straightaway, visibility was good on both sides of the road. On curves, visibility was inadequate in all 4 tests.

On the straightaway, visibility was inadequate on both sides of the road. On curves, visibility was inadequate in all 4 tests.

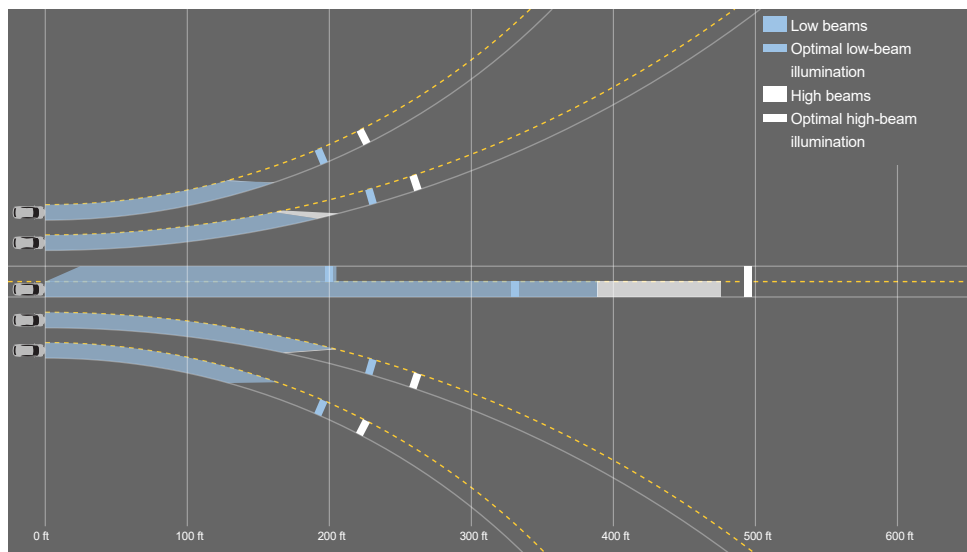
Distance at which headlights provide at least 5 lux illumination:

On the straightaway, visibility was good on both sides of the road. On curves, visibility was inadequate in all 4 tests.

On the straightaway, visibility was good on the right side of the road and inadequate on the left side. On curves, visibility was inadequate in all 4 tests.

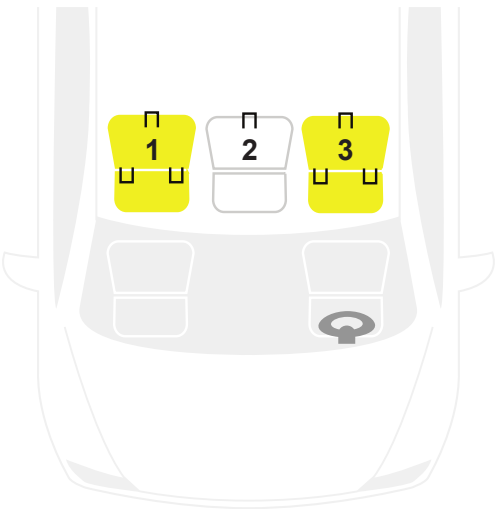
This vehicle has 2 rear seating positions with complete child seat attachment (LATCH) hardware. It has 1 additional seating position with a tether anchor only.
